Geotechnical Feasibility Investigation at 39 Launch Road, Hobsonville Point

Job No. 211053

**GEOTECHNICAL INVESTIGATION
FOR FEASIBILITY OF FUTURE DEVELOPMENT
39 LAUNCH ROAD, HOBSONVILLE**

Job Number:	211053
Name of Project:	39 Launch Road, Hobsonville Point
Client:	Kainga Ora
Author:	Martin Williams, Geotechnical Engineer, MEngNZ
Reviewer / Authoriser:	Bruce Green, Principal Geotechnical Engineer, CMEngNZ, CPEng
Document Version:	A
Printed:	26 November 2021
Author Signature:	
Reviewer / Authoriser Signature:

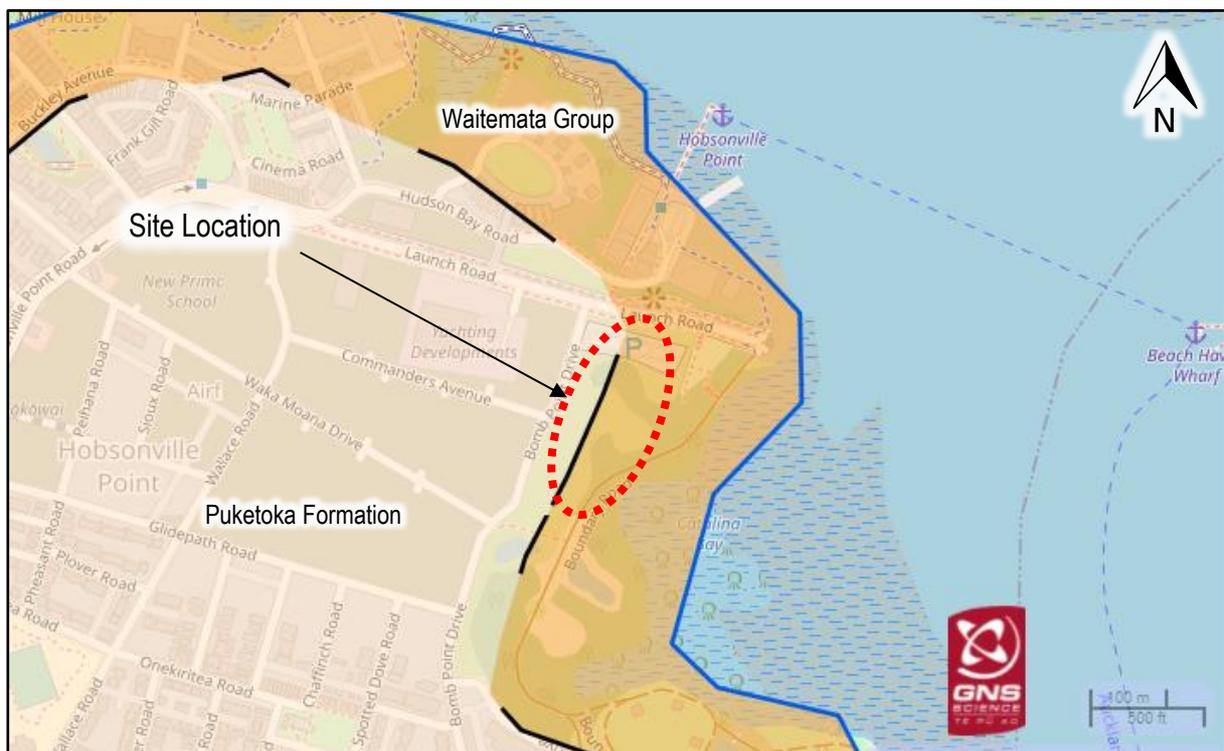
Figure 2: Geological Map (Source: GNS WebMaps Website)

Holocene Alluvium

This material is usually wet-to-saturated, weak and muddy and is typically localised, usually along stream channels or present along deeper overland flow paths. This material requires removal if the area it occupies is to be filled and is not suited to support of any kind of structure.

Puketoka Formation

Alluvial soils are often susceptible to consolidation (resulting in settlement) when subjected to foundation or fill loads, particularly where organic soils (e.g. Peats) are present. In addition, these soils shrink and swell with soil moisture content changes and can be sensitive, often rapidly losing strength in response to disturbance by construction plant and/or exposure to the elements.

Waitemata Group

Waitemata Group soils are derived from weathering of the parent sedimentary sandstones and siltstones to form a mantle of residual soils typically comprising firm to very stiff clays, silts, and sands of variable plasticity. These soils are prone to shrinking and swelling with variations in soil moisture content.

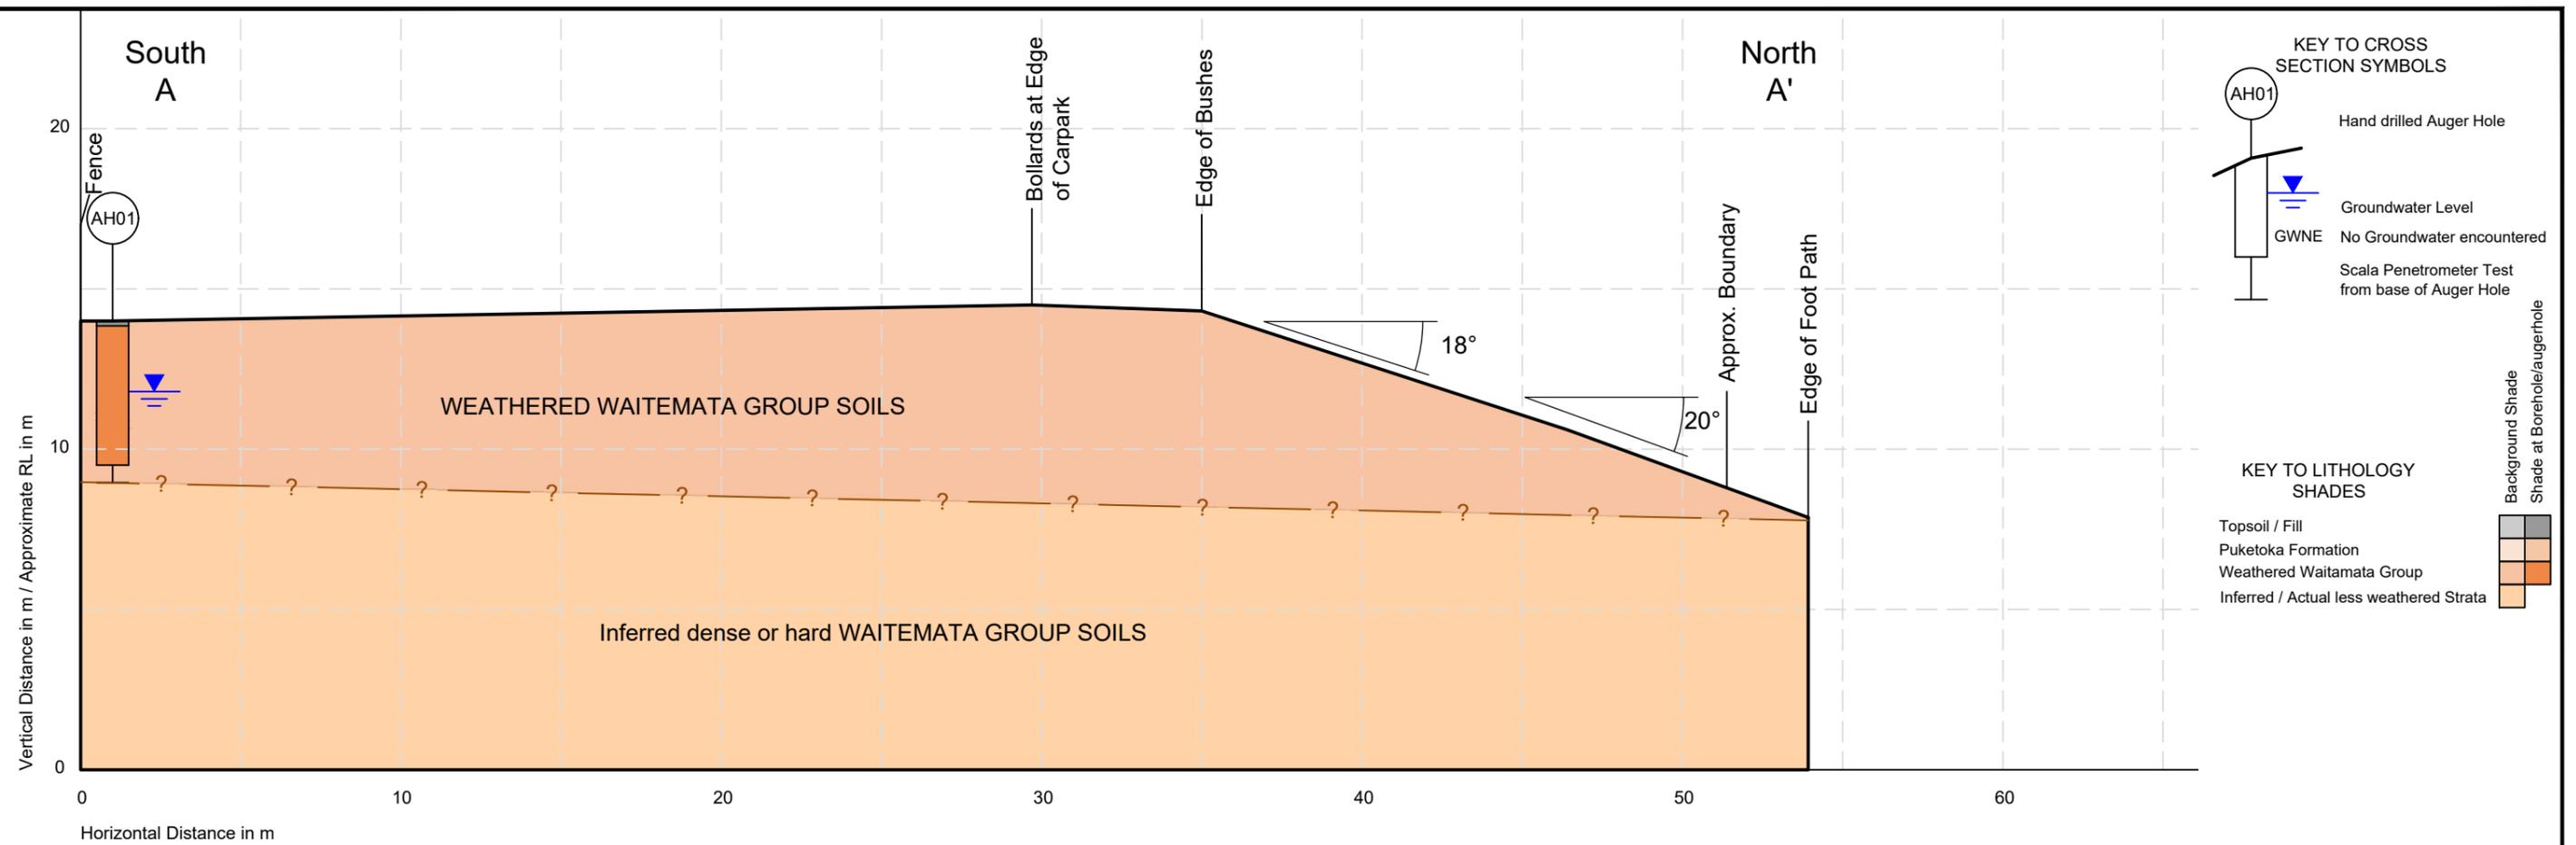
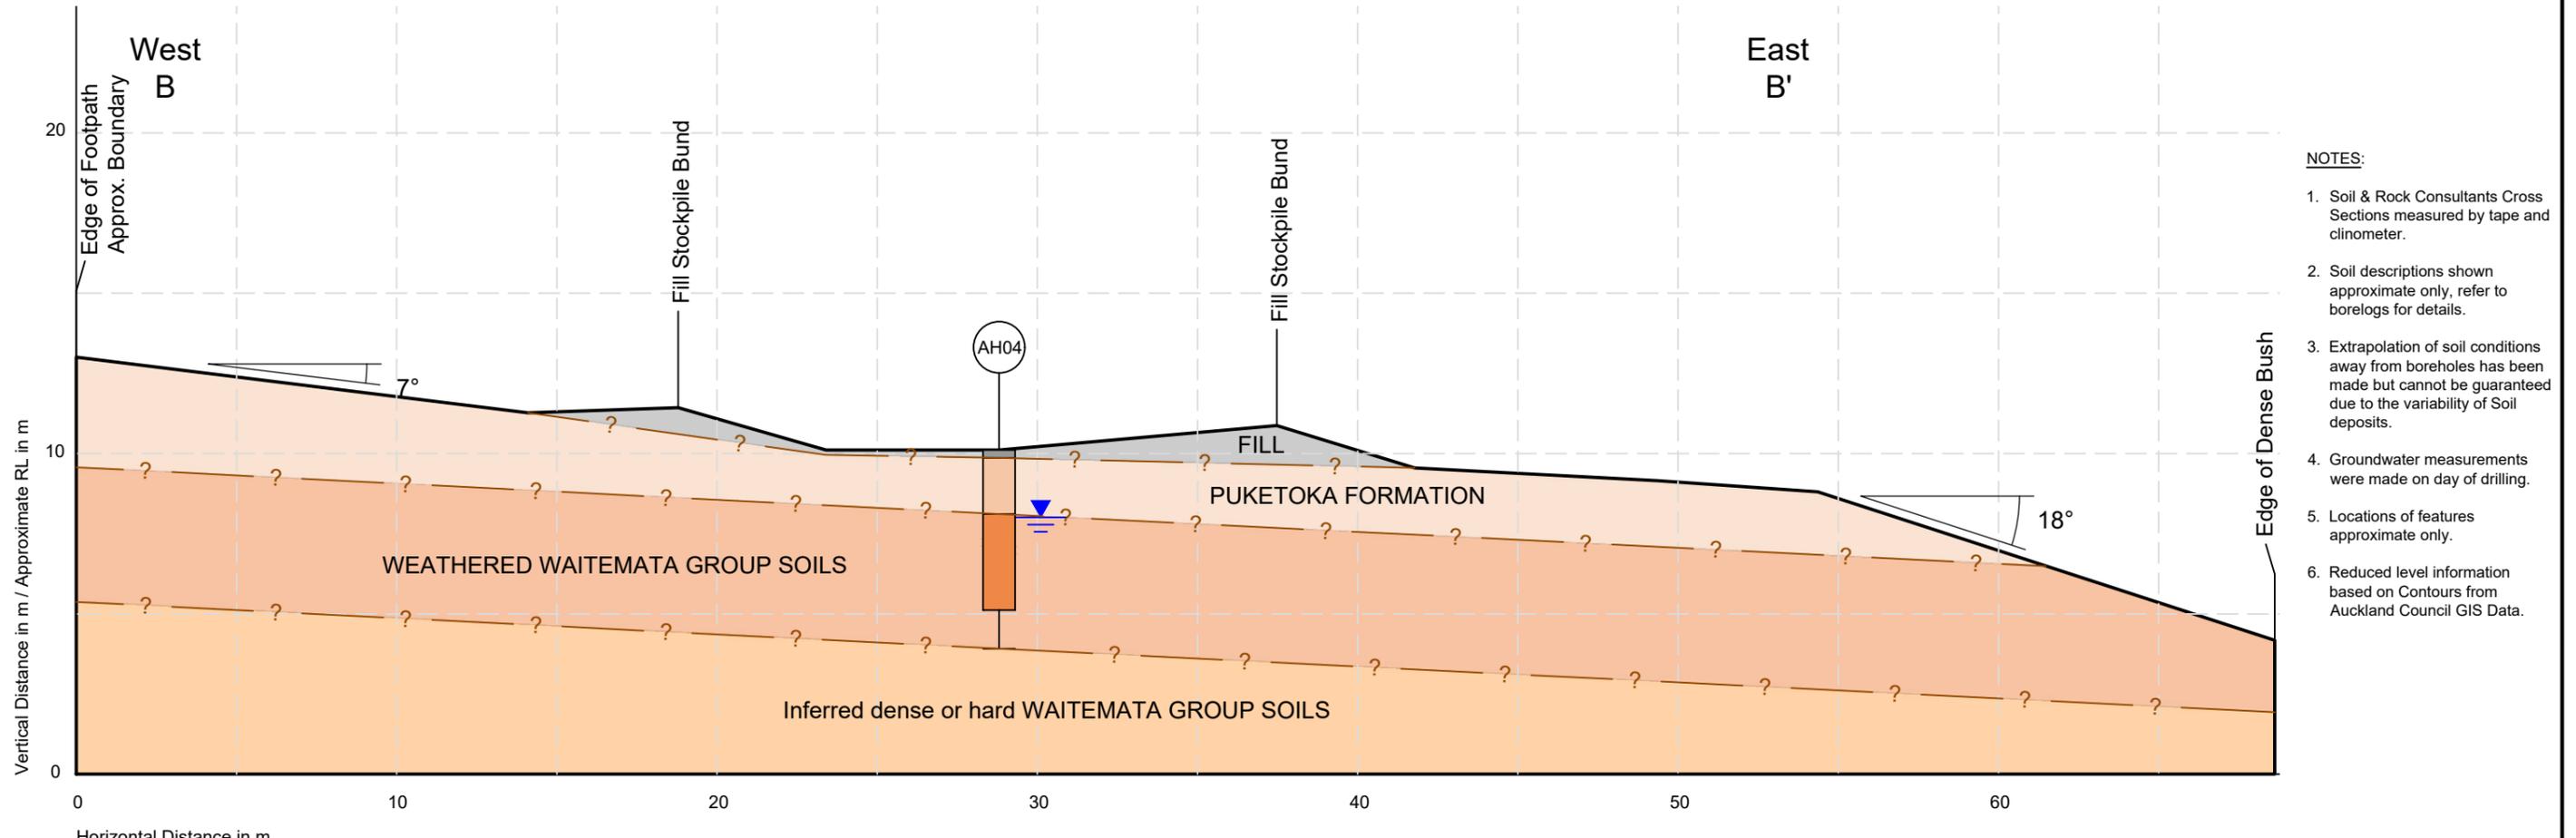
Drawings – Soil & Rock Consultants Site Plan & Geological Sections

- NOTES:**
- Soil & Rock Consultants Cross Sections measured by tape and clinometer.
 - Soil descriptions shown approximate only, refer to borelogs for details.
 - Extrapolation of soil conditions away from boreholes has been made but cannot be guaranteed due to the variability of Soil deposits.
 - Groundwater measurements were made on day of drilling.
 - Locations of features approximate only.
 - Reduced level information based on Contours from Auckland Council GIS Data.

The test locations are shown on the Site Plan, Drawing No 211053/1 (Appendix A). The locations were measured from existing site features using a hand-held tape or determined from hand-held GPS and are therefore approximate only.

Cross Section BB' on Drawing 211053/2 is representative of fill stockpiles at the southern end of the site. These are easily visible as they are stockpiles however fill as described in the handauger holes is not obvious and requires investigation to quantify volumes and spread.

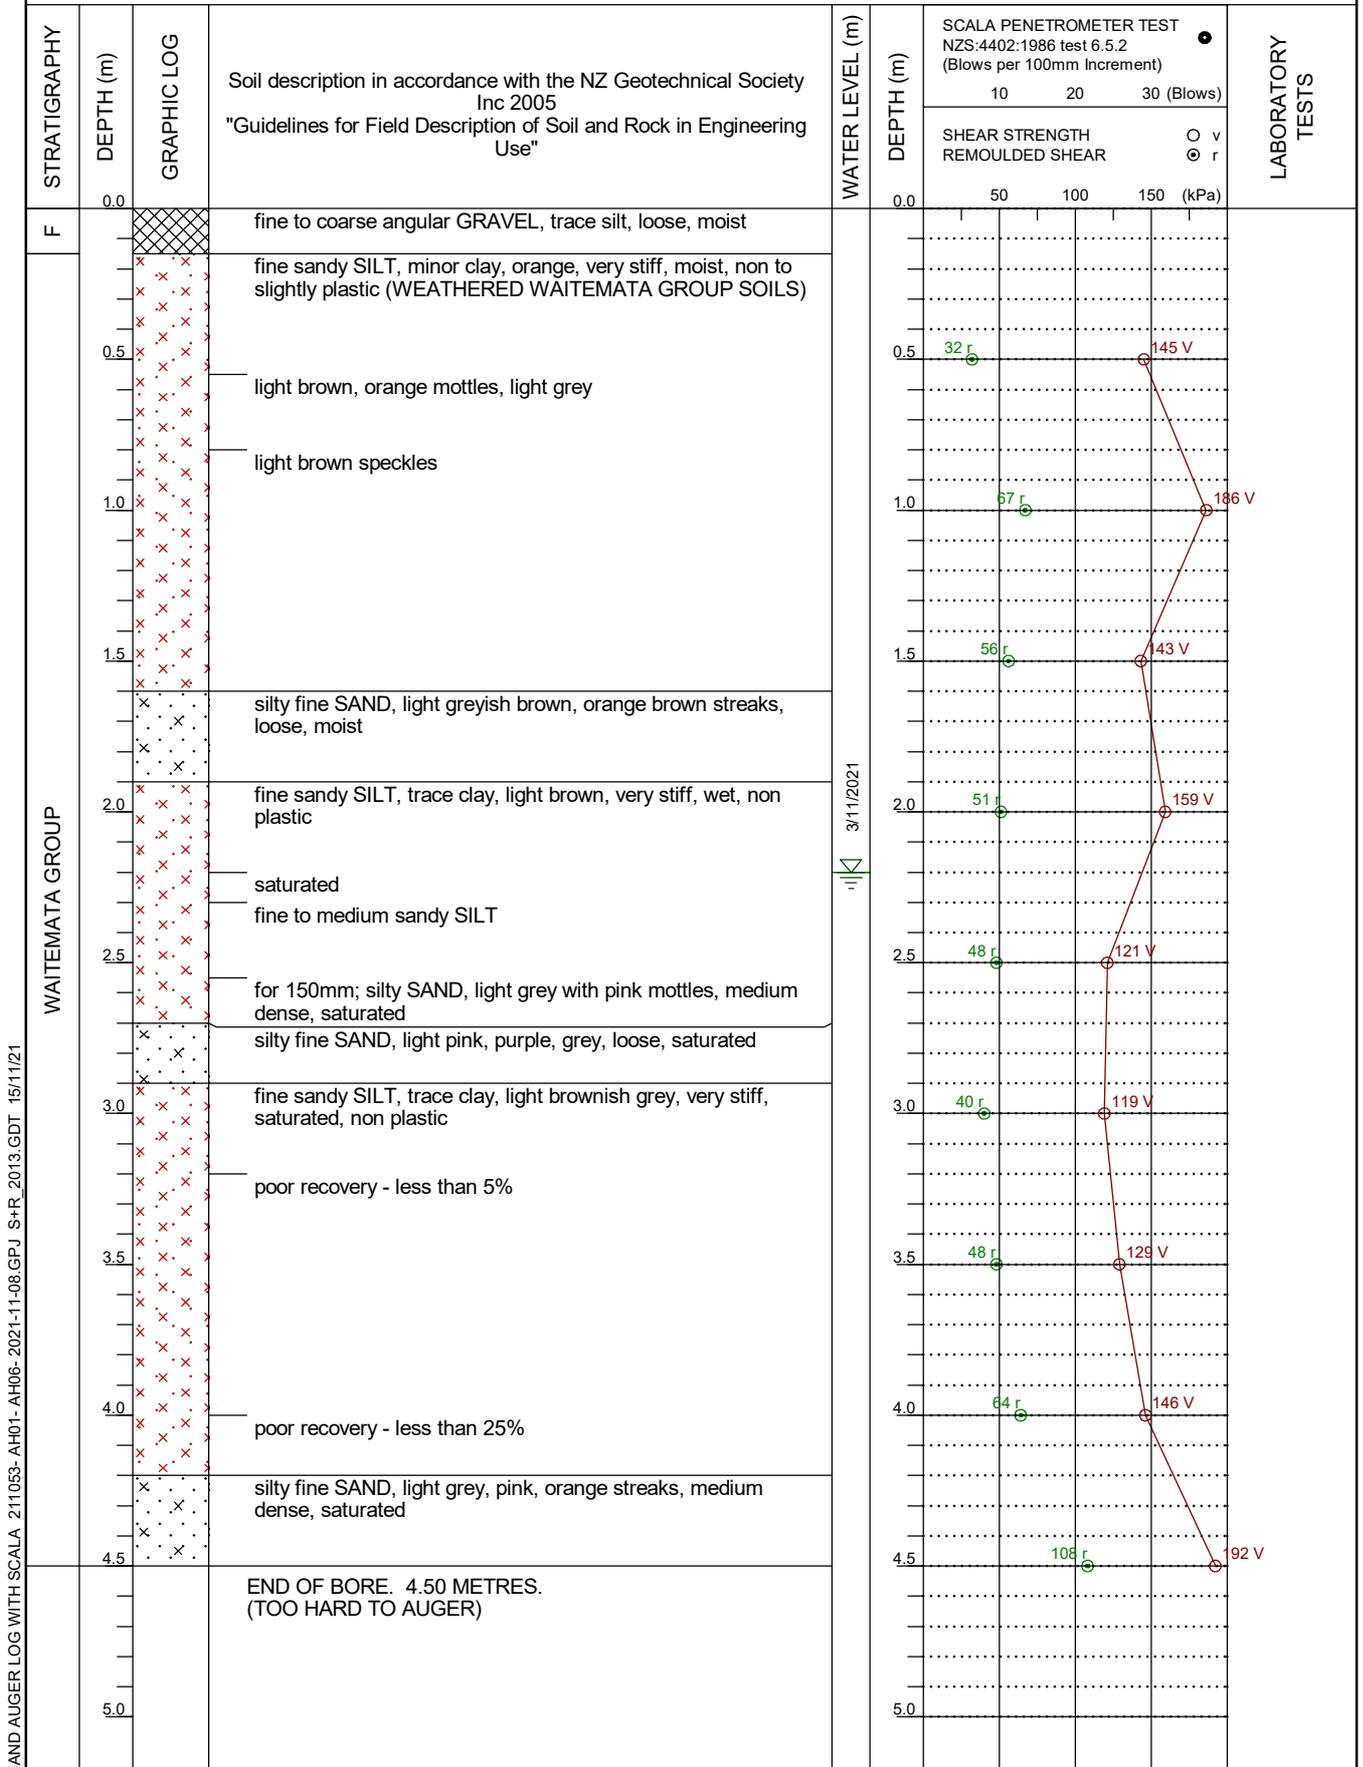
HAND AUGER LOG WITH SCALA 211053-AH01-AH06-2021-11-08.GPJ S+R 2013.GDT 15/11/21

Drill Type: 50mmØ Hand Auger Project No: 211053 Logged By: NN
 Drilled By: NN Coordinates: Shear Vane No - Calibration Date: GEO604 - 24/11/2020
 Date Started: 3/11/21 Ground Elevation: Surface Conditions: Near Level, Gravel
 Date Finished: 3/11/21 Water Level: 2.2m 3/11/2021

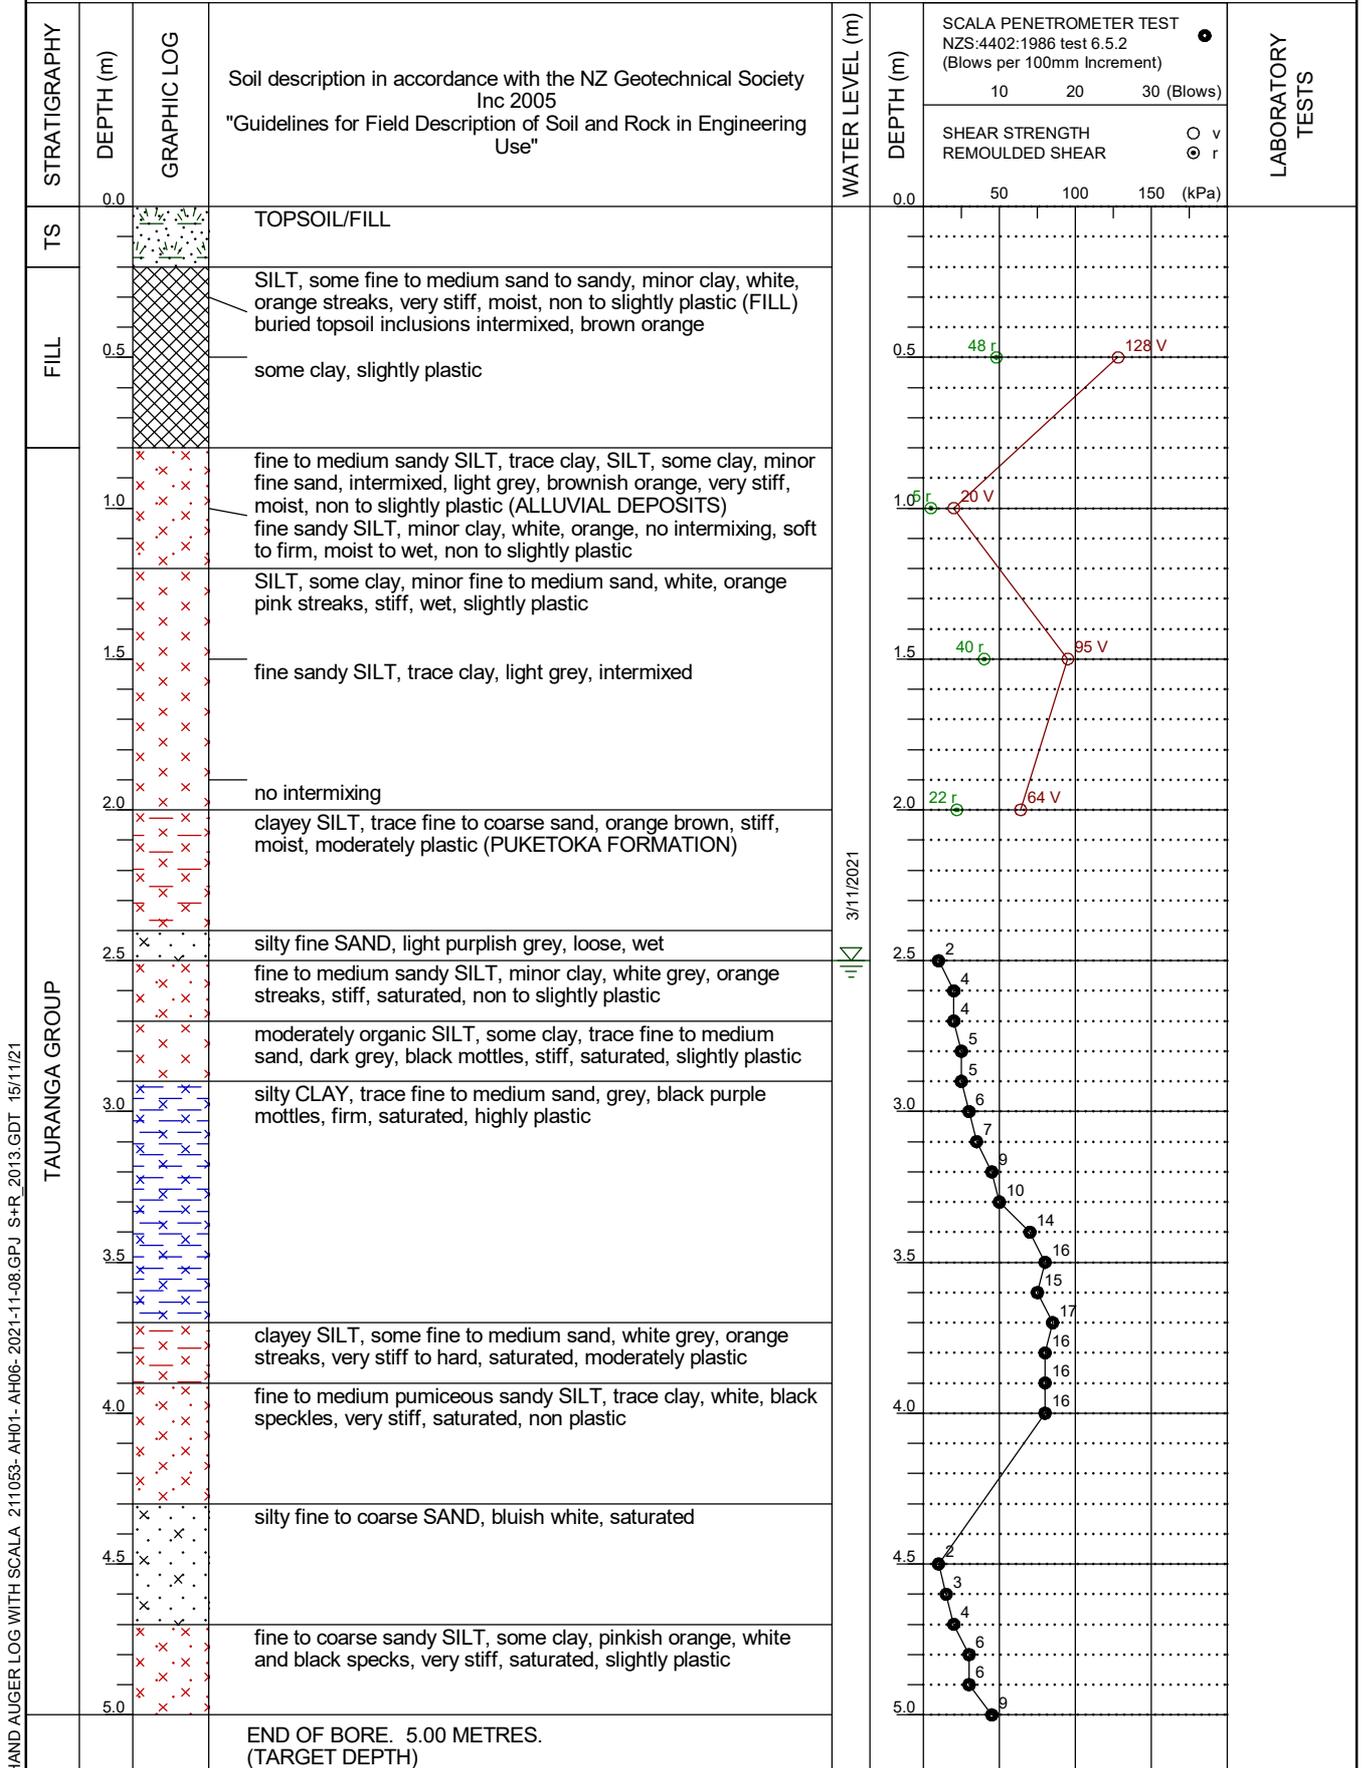
HAND AUGER LOG WITH SCALA 211053-AH01-AH06-2021-11-08.GPJ S+R 2013.GDT 15/11/21

Drill Type: 50mmØ Hand Auger Project No: 211053 Logged By: RH
 Drilled By: RH Coordinates: Shear Vane No - Calibration Date: GEO765 - 10/03/2021
 Date Started: 3/11/21 Ground Elevation: Surface Conditions: Near Level, Grass
 Date Finished: 3/11/21 Water Level: 2.5m 3/11/2021

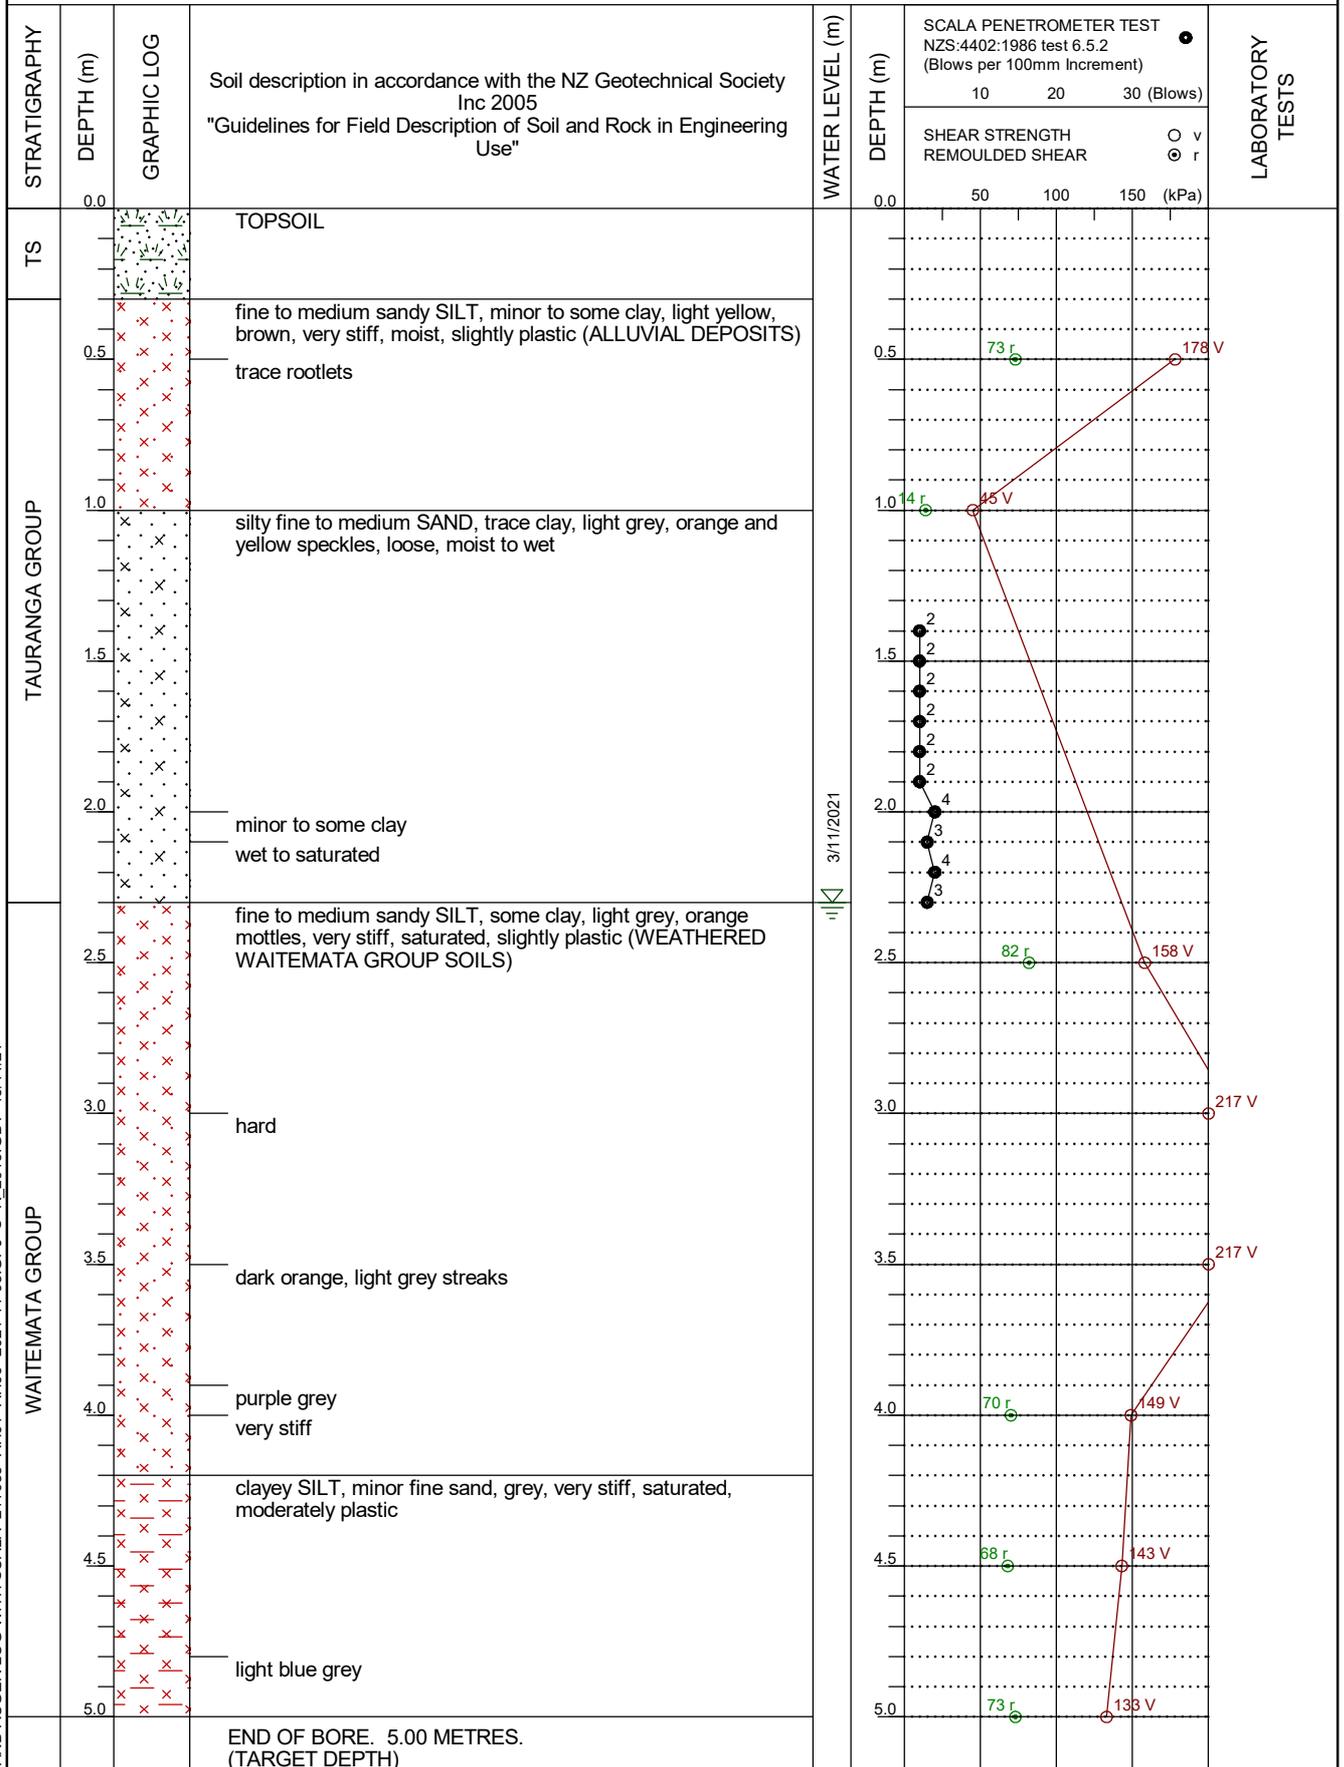
HAND AUGER LOG WITH SCALA 211053-AH01-AH06-2021-11-08.GPJ S+R_2013.GDT 15/11/21

Drill Type: 50mmØ Hand Auger Project No: 211053 Logged By: JT
 Drilled By: JT Coordinates: Shear Vane No - Calibration Date: GEO1591 - 5/03/2021
 Date Started: 3/11/21 Ground Elevation: Surface Conditions: Near Level, Gravel
 Date Finished: 3/11/21 Water Level: 2.3m 3/11/2021

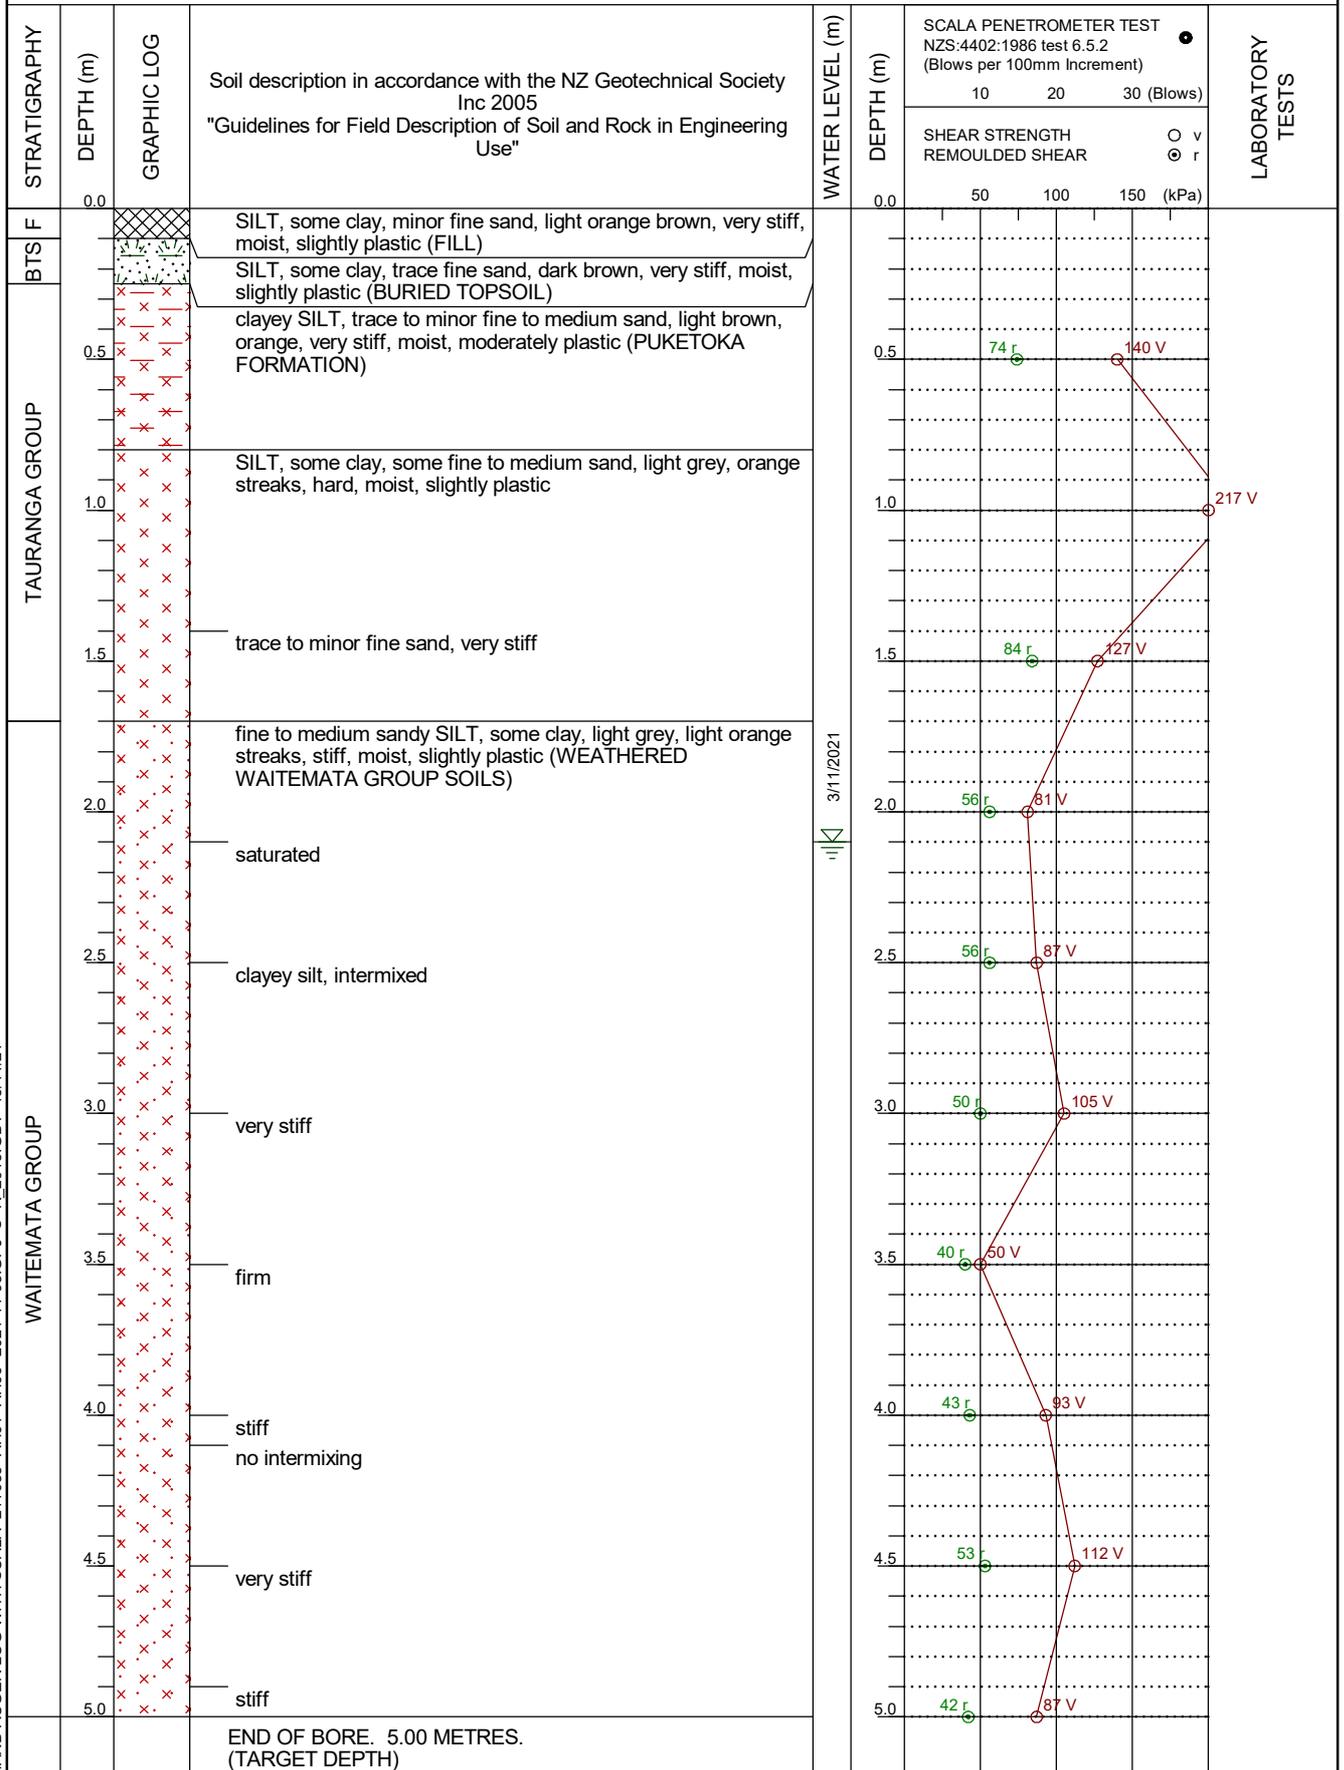
HAND AUGER LOG WITH SCALA 211053-AH01-AH06-2021-11-08.GPJ S+R_2013.GDT 15/11/21

Drill Type: 50mmØ Hand Auger Project No: 211053 Logged By: JT
 Drilled By: JT Coordinates: Shear Vane No - Calibration Date: GEO1591 - 5/03/2021
 Date Started: 3/11/21 Ground Elevation: Surface Conditions: Near Level, Soil
 Date Finished: 3/11/21 Water Level: 2.1m 3/11/2021

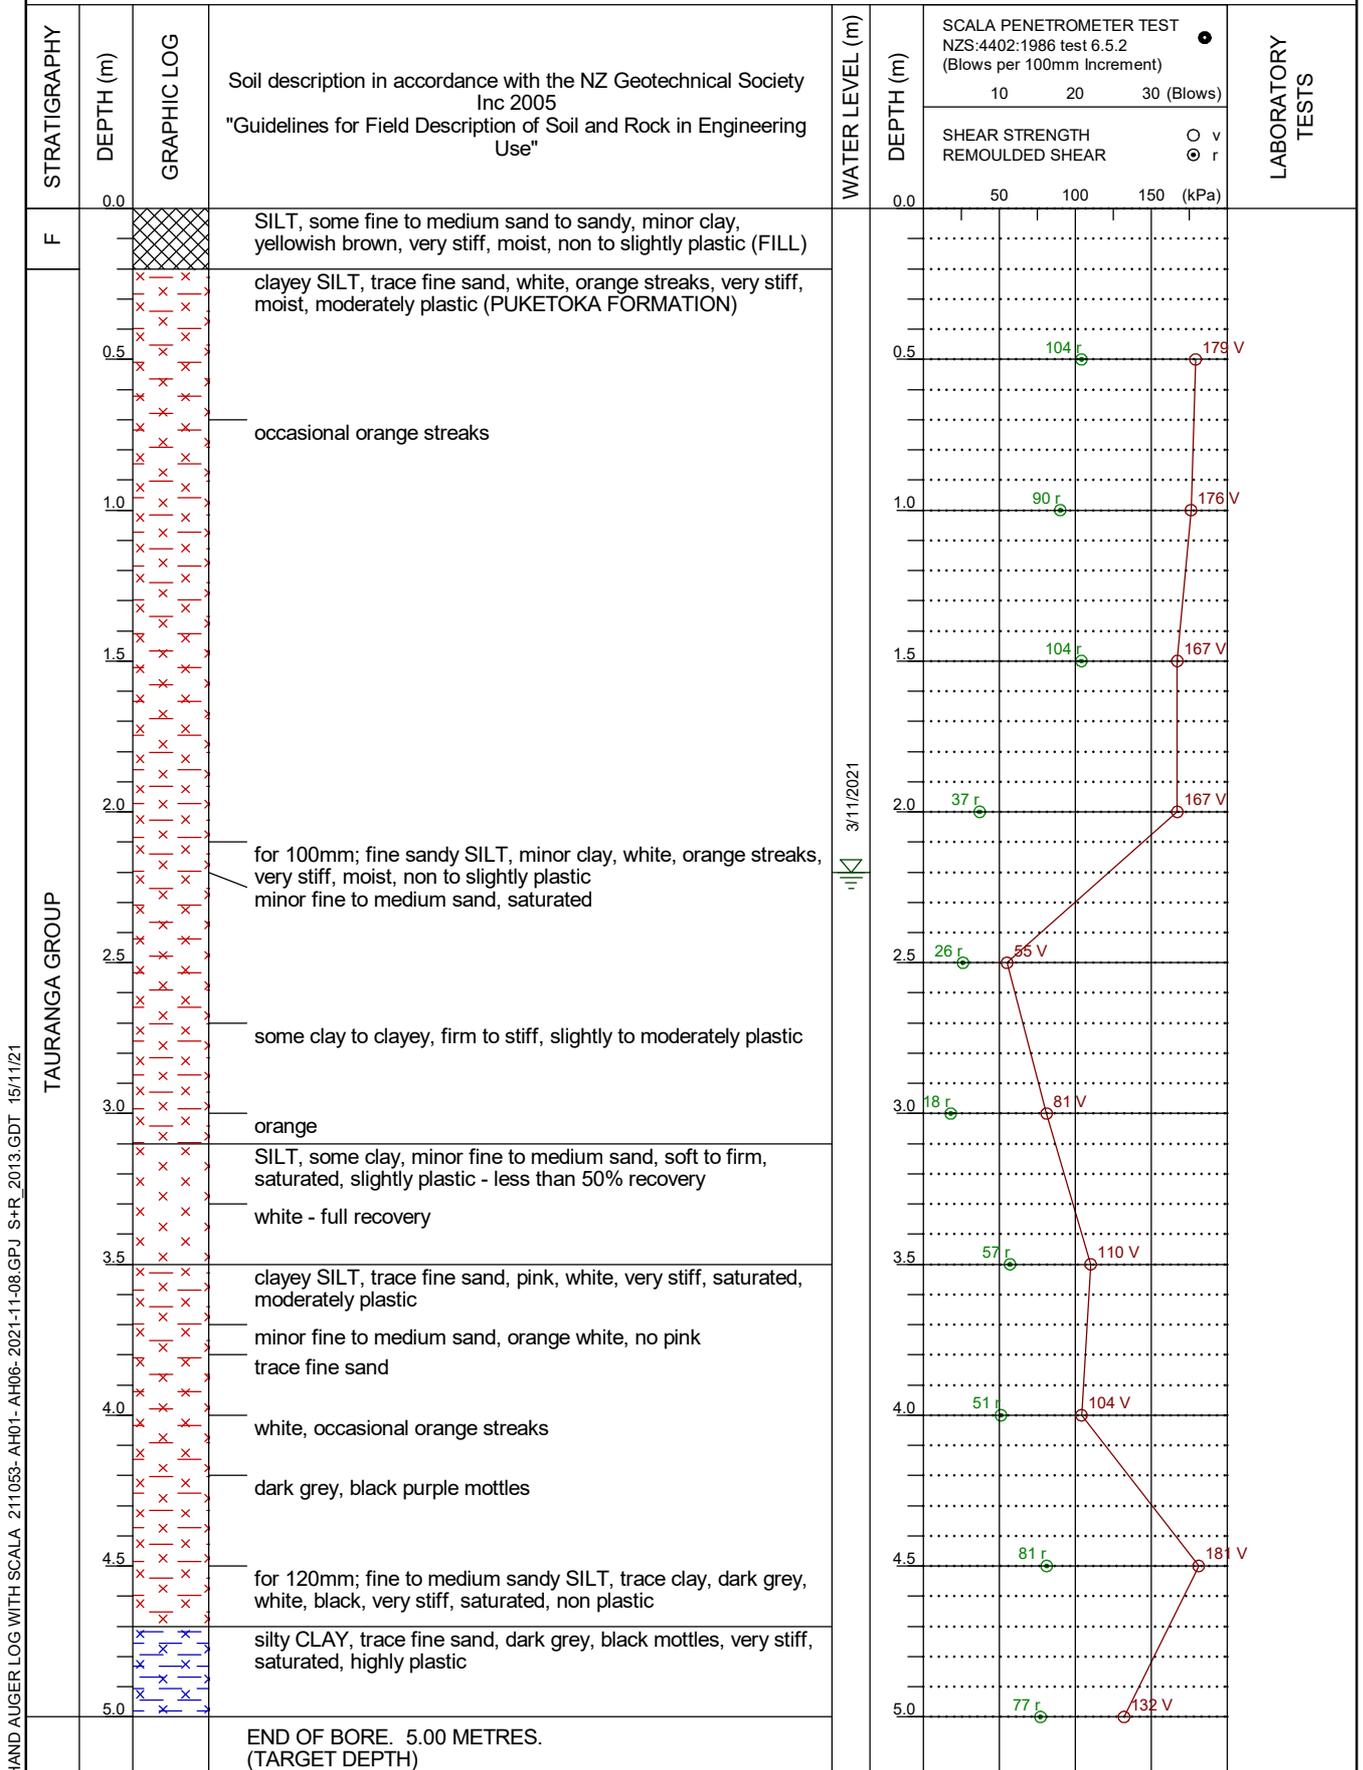
HAND AUGER LOG WITH SCALA 211053-AH01-AH06-2021-11-08.GPJ S+R 2013.GDT 15/11/21

Drill Type: 50mmØ Hand Auger Project No: 211053 Logged By: RH
 Drilled By: RH Coordinates: Shear Vane No - Calibration Date: GEO765 - 10/03/2021
 Date Started: 3/11/21 Ground Elevation: Surface Conditions: Near Level, Soil
 Date Finished: 3/11/21 Water Level: 2.2m 3/11/2021

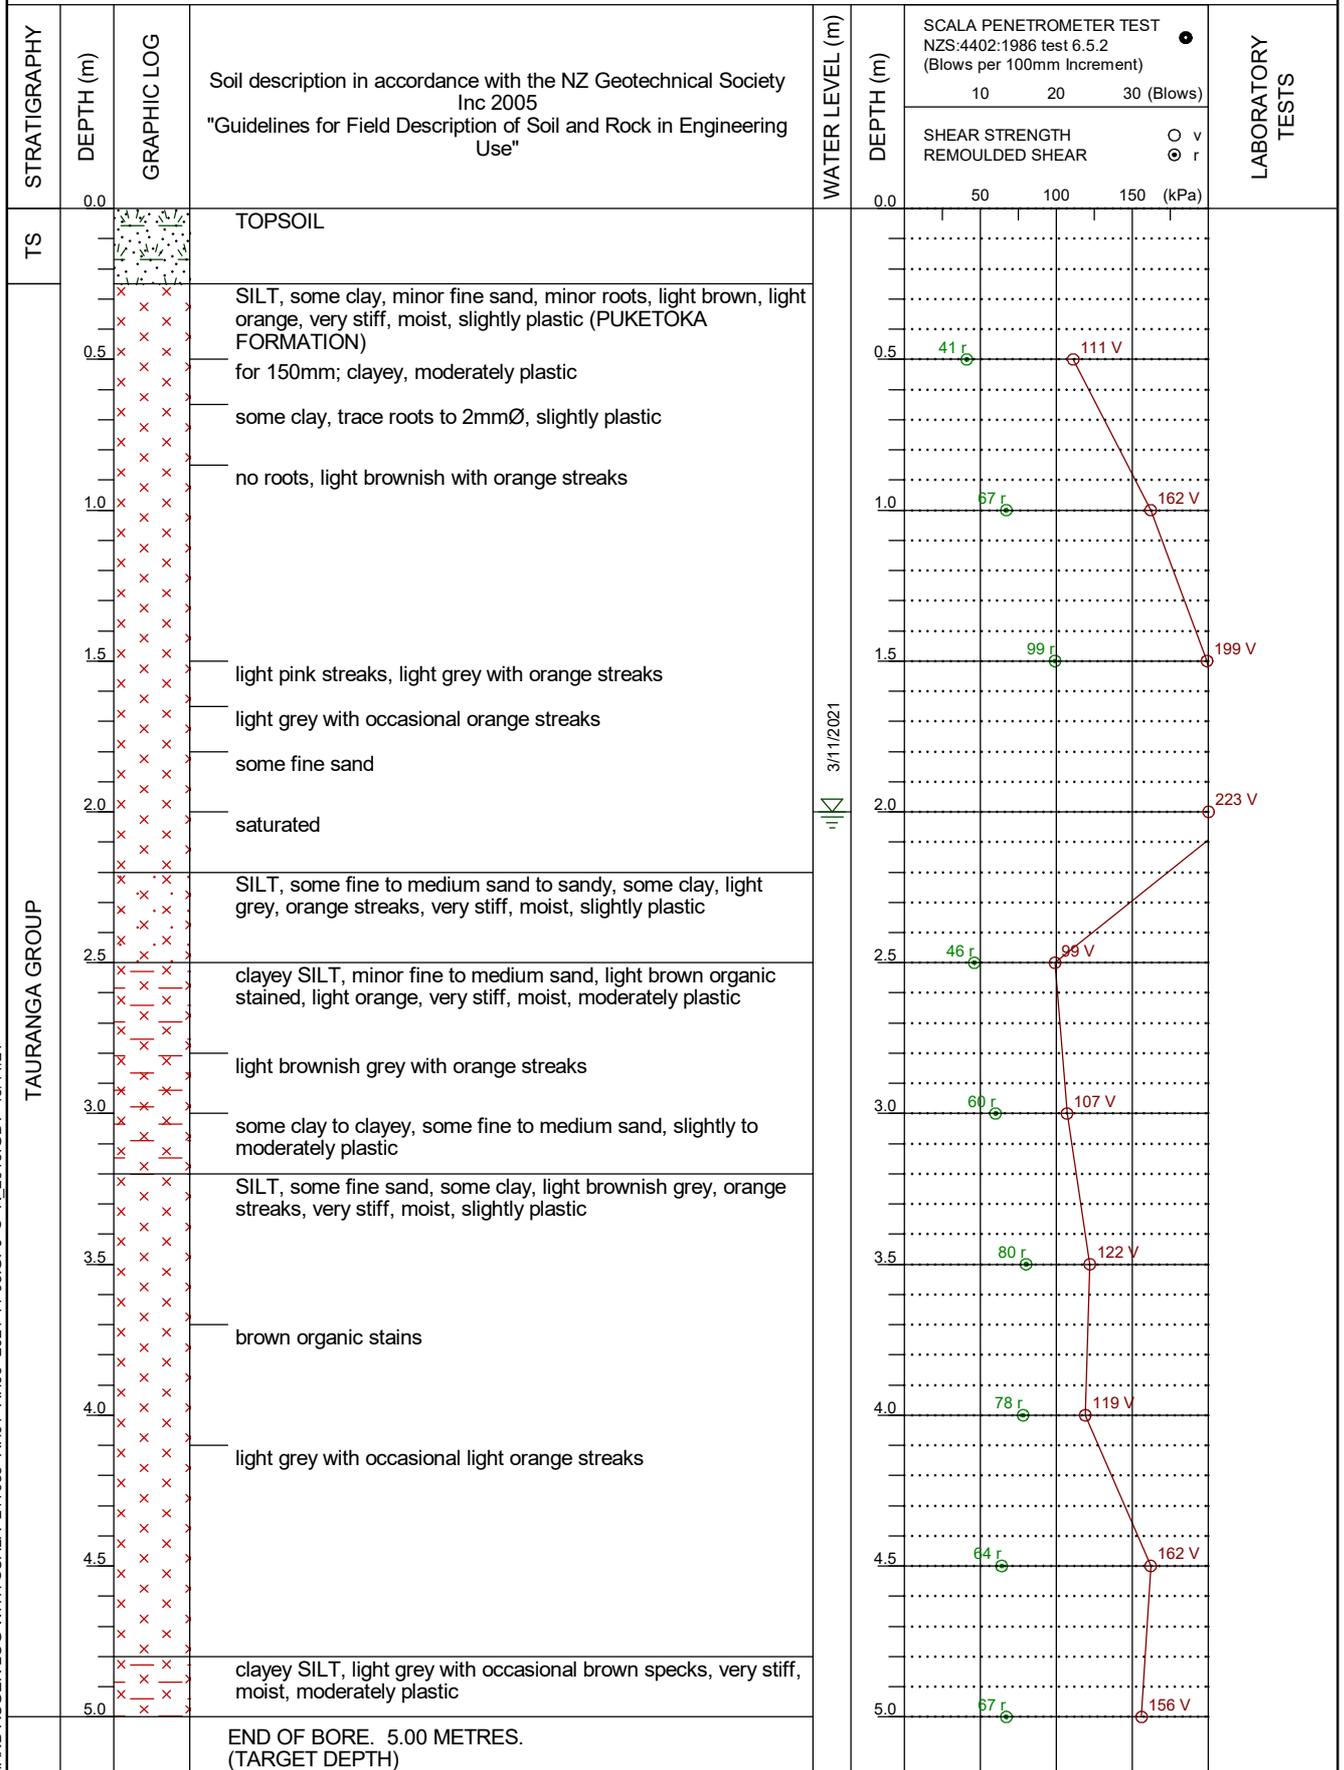
HAND AUGER LOG WITH SCALA 211053-AH01-AH06-2021-11-08.GPJ S+R 2013.GDT 15/11/21

Drill Type: 50mmØ Hand Auger Project No: 211053 Logged By: NN
 Drilled By: NN Coordinates: Shear Vane No - Calibration Date: GEO604 - 24/11/2020
 Date Started: 3/11/21 Ground Elevation: Surface Conditions: Slightly Sloping, Grass
 Date Finished: 3/11/21 Water Level: 2.0m 3/11/2021
