Geotechnical Feasibility Investigation at 39 Launch Road, Hobsonville Point

Job No. 211053

**GEOTECHNICAL INVESTIGATION
FOR FEASIBILITY OF FUTURE DEVELOPMENT
39 LAUNCH ROAD, HOBSONVILLE**

Job Number:	211053
Name of Project:	39 Launch Road, Hobsonville Point
Client:	Kainga Ora
Author:	Martin Williams, Geotechnical Engineer, MEngNZ
Reviewer / Authoriser:	Bruce Green, Principal Geotechnical Engineer, CMEngNZ, CPEng
Document Version:	A
Printed:	26 November 2021
Author Signature:	
Reviewer / Authoriser Signature:

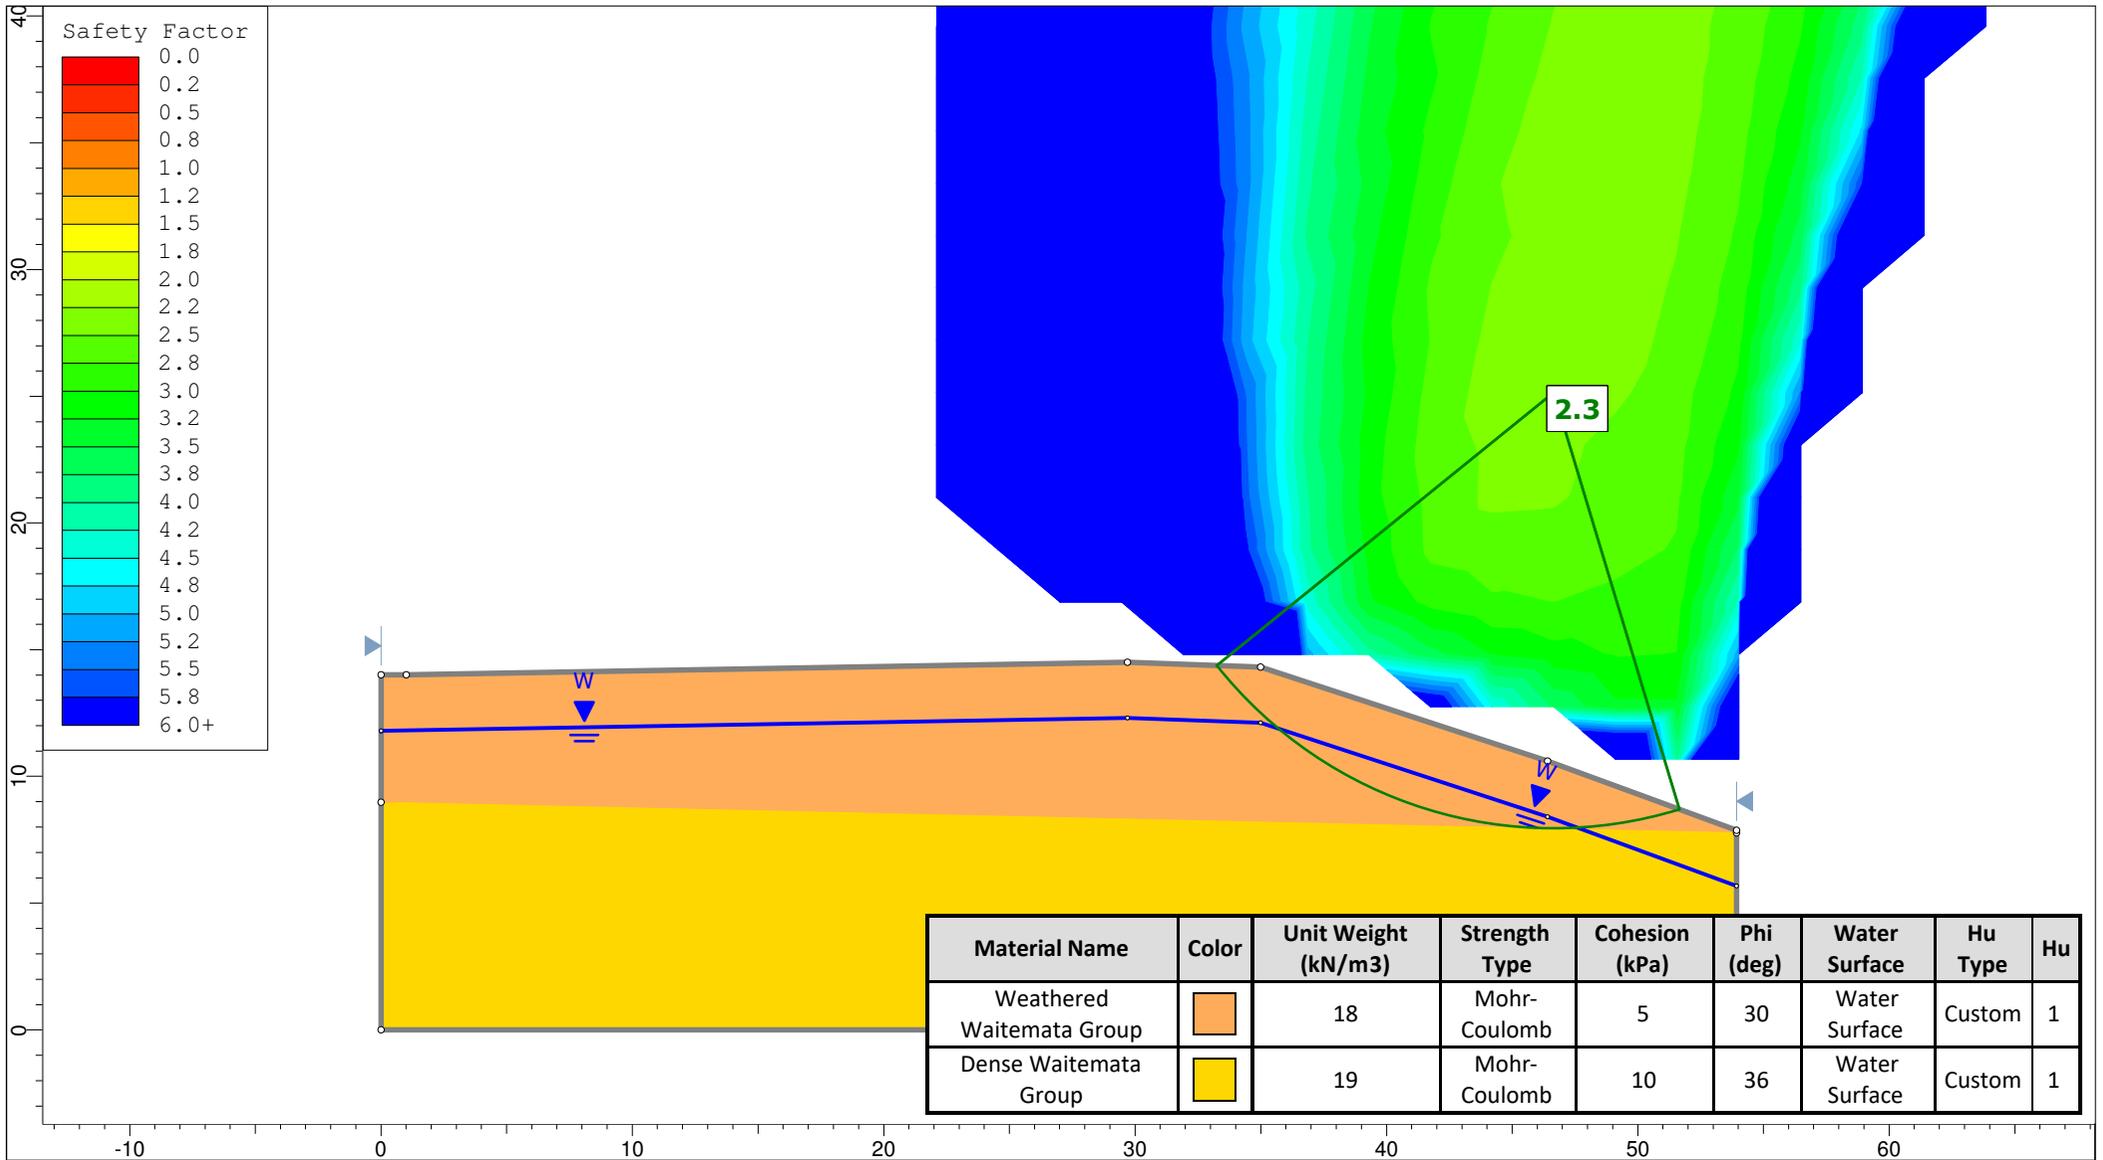
Material Name	Color	Unit Weight (kN/m ³)	Strength Type	Cohesion (kPa)	Phi (deg)	Water Surface	Hu Type	Hu
Weathered Waitemata Group

Soil & Rock Consultants <i>Your responsive & cost-effective engineers</i>	Project		39 Launch Road			
	Group		Section AA		Scenario	Measured GWT
	Drawn By	MW	Scale	1:300	Company	Soil & Rock Consultants
	Date	17/11/2021	File Name	211053 Slide.slmd

Section	Modelled Conditions	Global Factor of Safety		Compliant
		Required	Calculated	
A-A'	Measured Groundwater	1.5	2.3	Yes
	Extreme (Worst Credible) Groundwater	1.3	1.8	Yes
	Seismic Loading	1.2	1.5	Yes
B-B'	Measured Groundwater	1.5	2.4	Yes
	Extreme (Worst Credible) Groundwater	1.3	2.0	Yes
	Seismic Loading	1.2	1.6	Yes

The global minimum FOS results given in Table 3 are greater than the Council requirements for all modelled conditions.

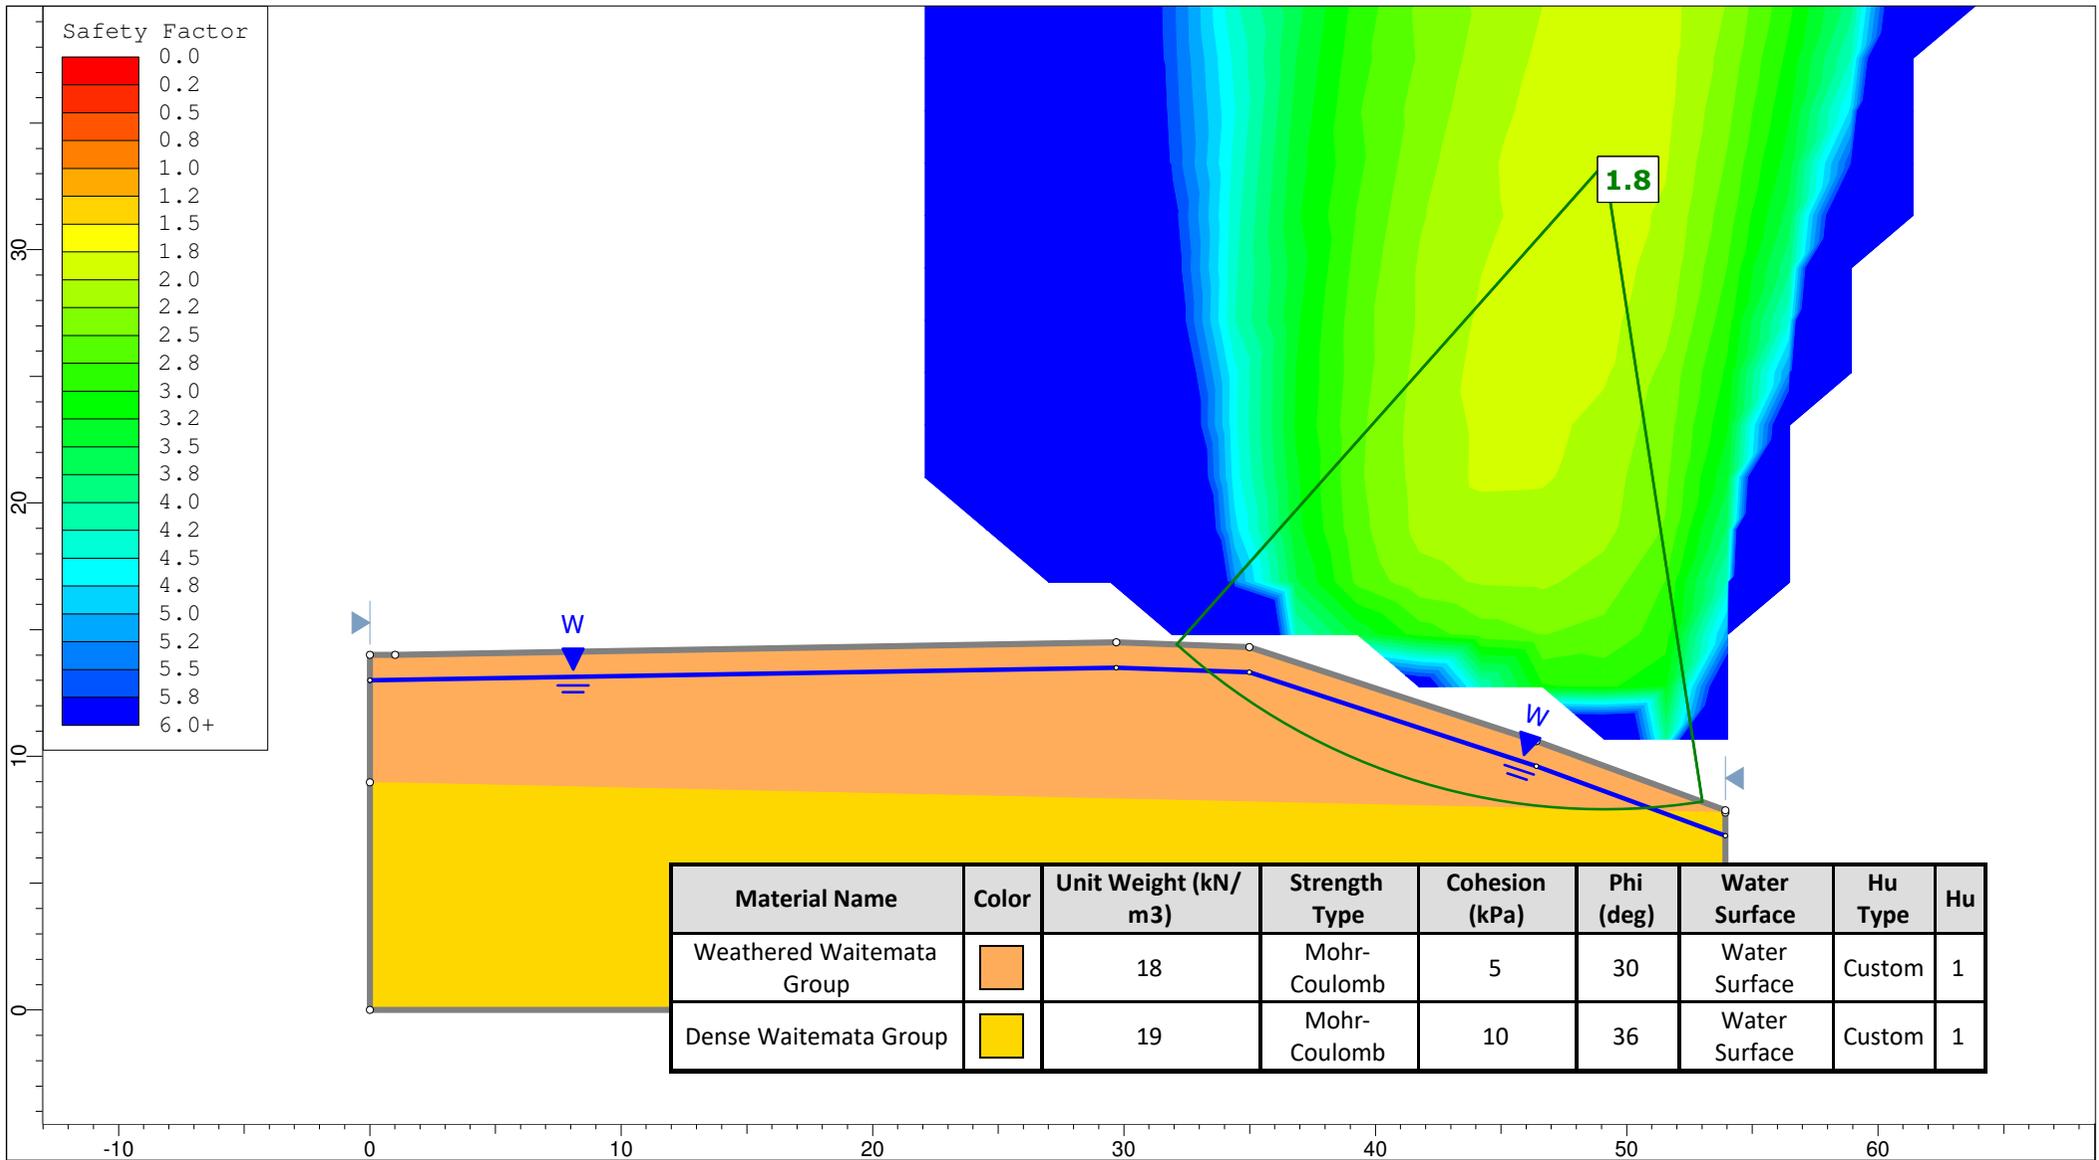
Soil&Rock Consultants <i>Your responsive & cost-effective engineers</i>	Project				39 Launch Road			
	Group		Section AA		Scenario		Raised GWT	
	Drawn By		Scale		Company		File Name	
	Date		17/11/2021		Soil & Rock Consultants		211053 Slide.slmd

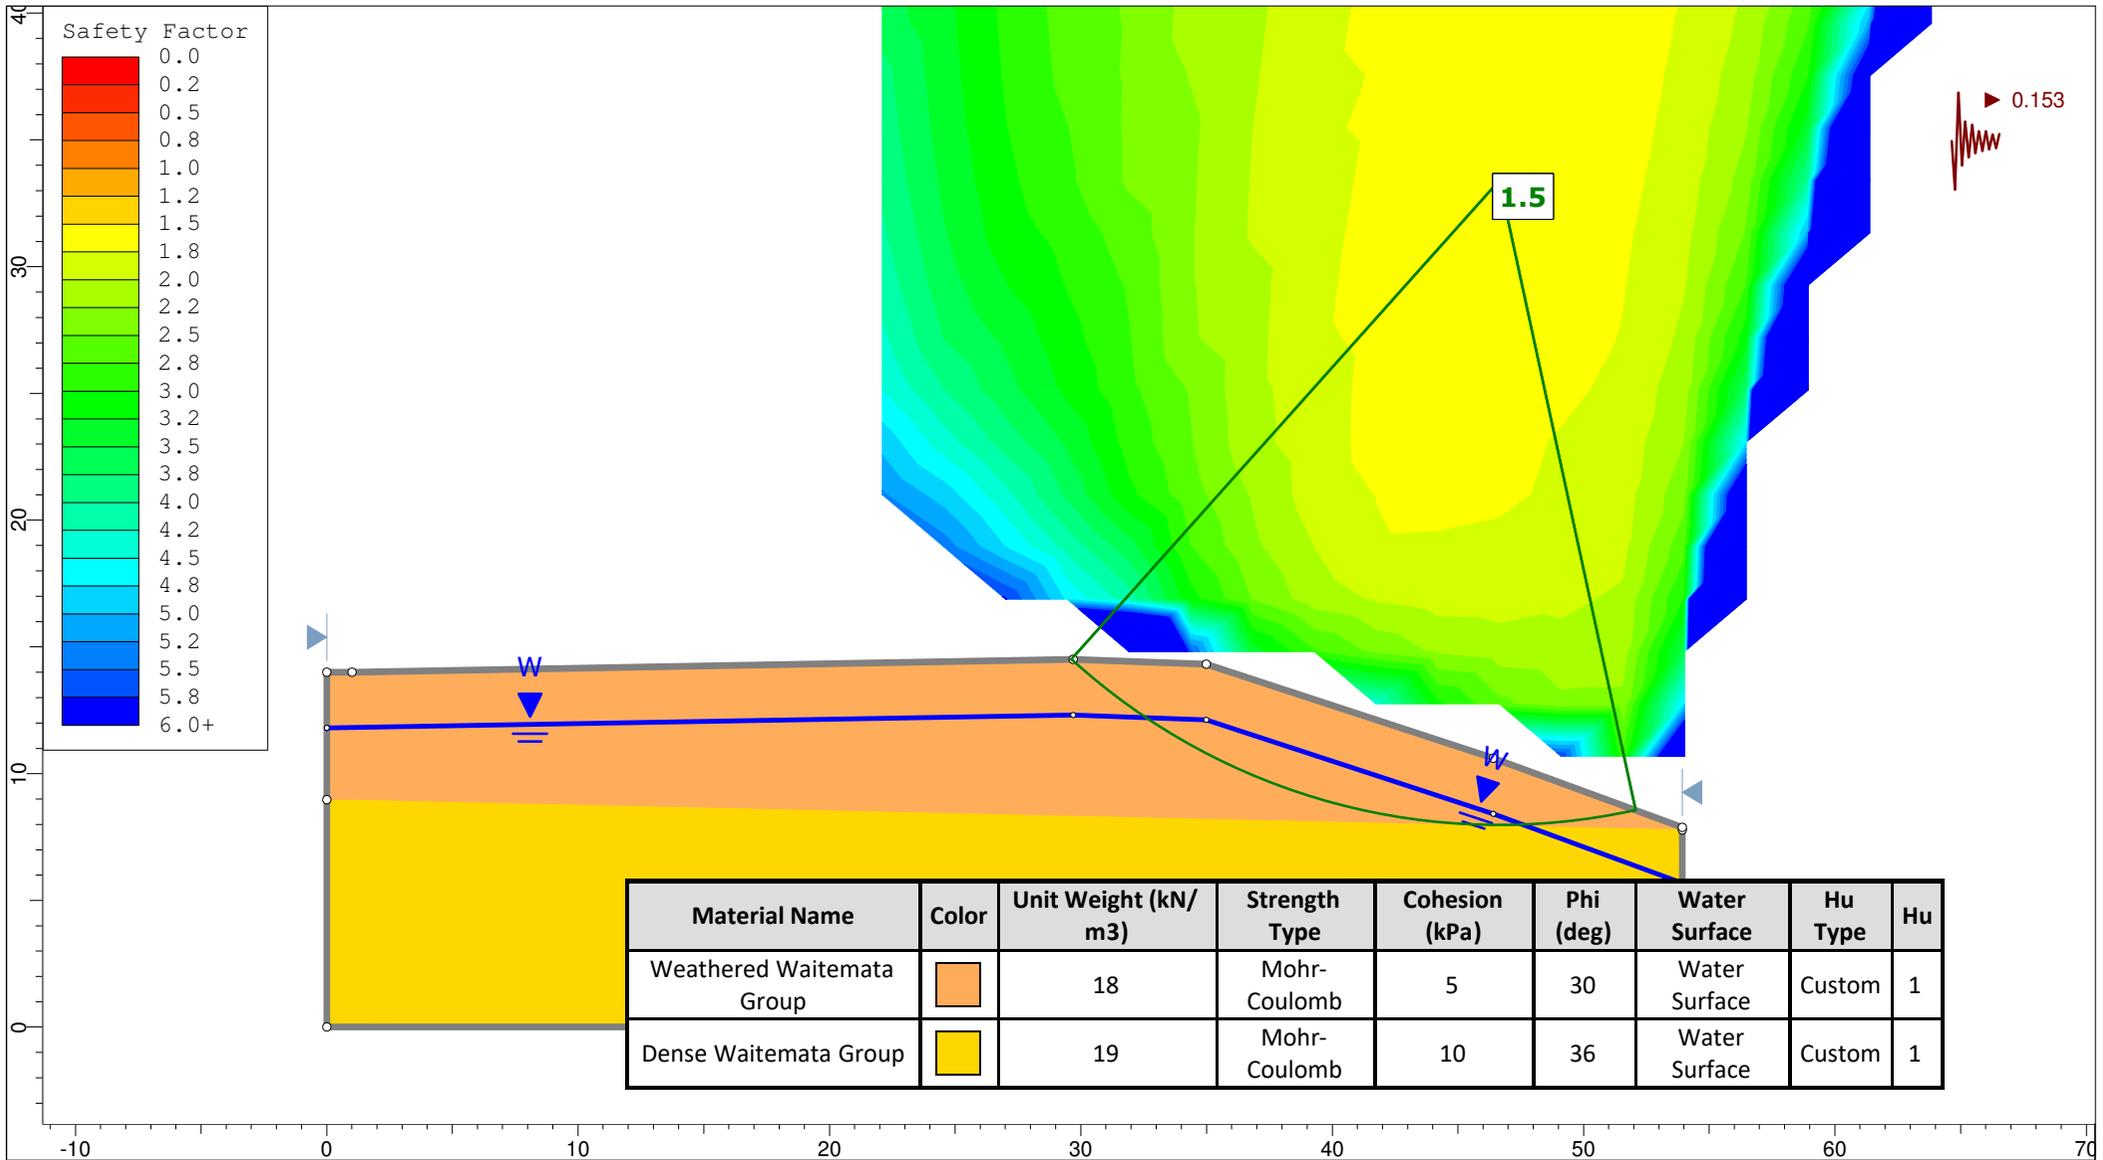
<p>Soil & Rock Consultants Your responsive & cost-effective engineers</p>	Project		39 Launch Road		
	Group		Section AA		
	Scenario		Seismic		
	Drawn By		Scale		
	MW	1:300	Company		
		Date		File Name	
		17/11/2021		211053 Slide.slmd

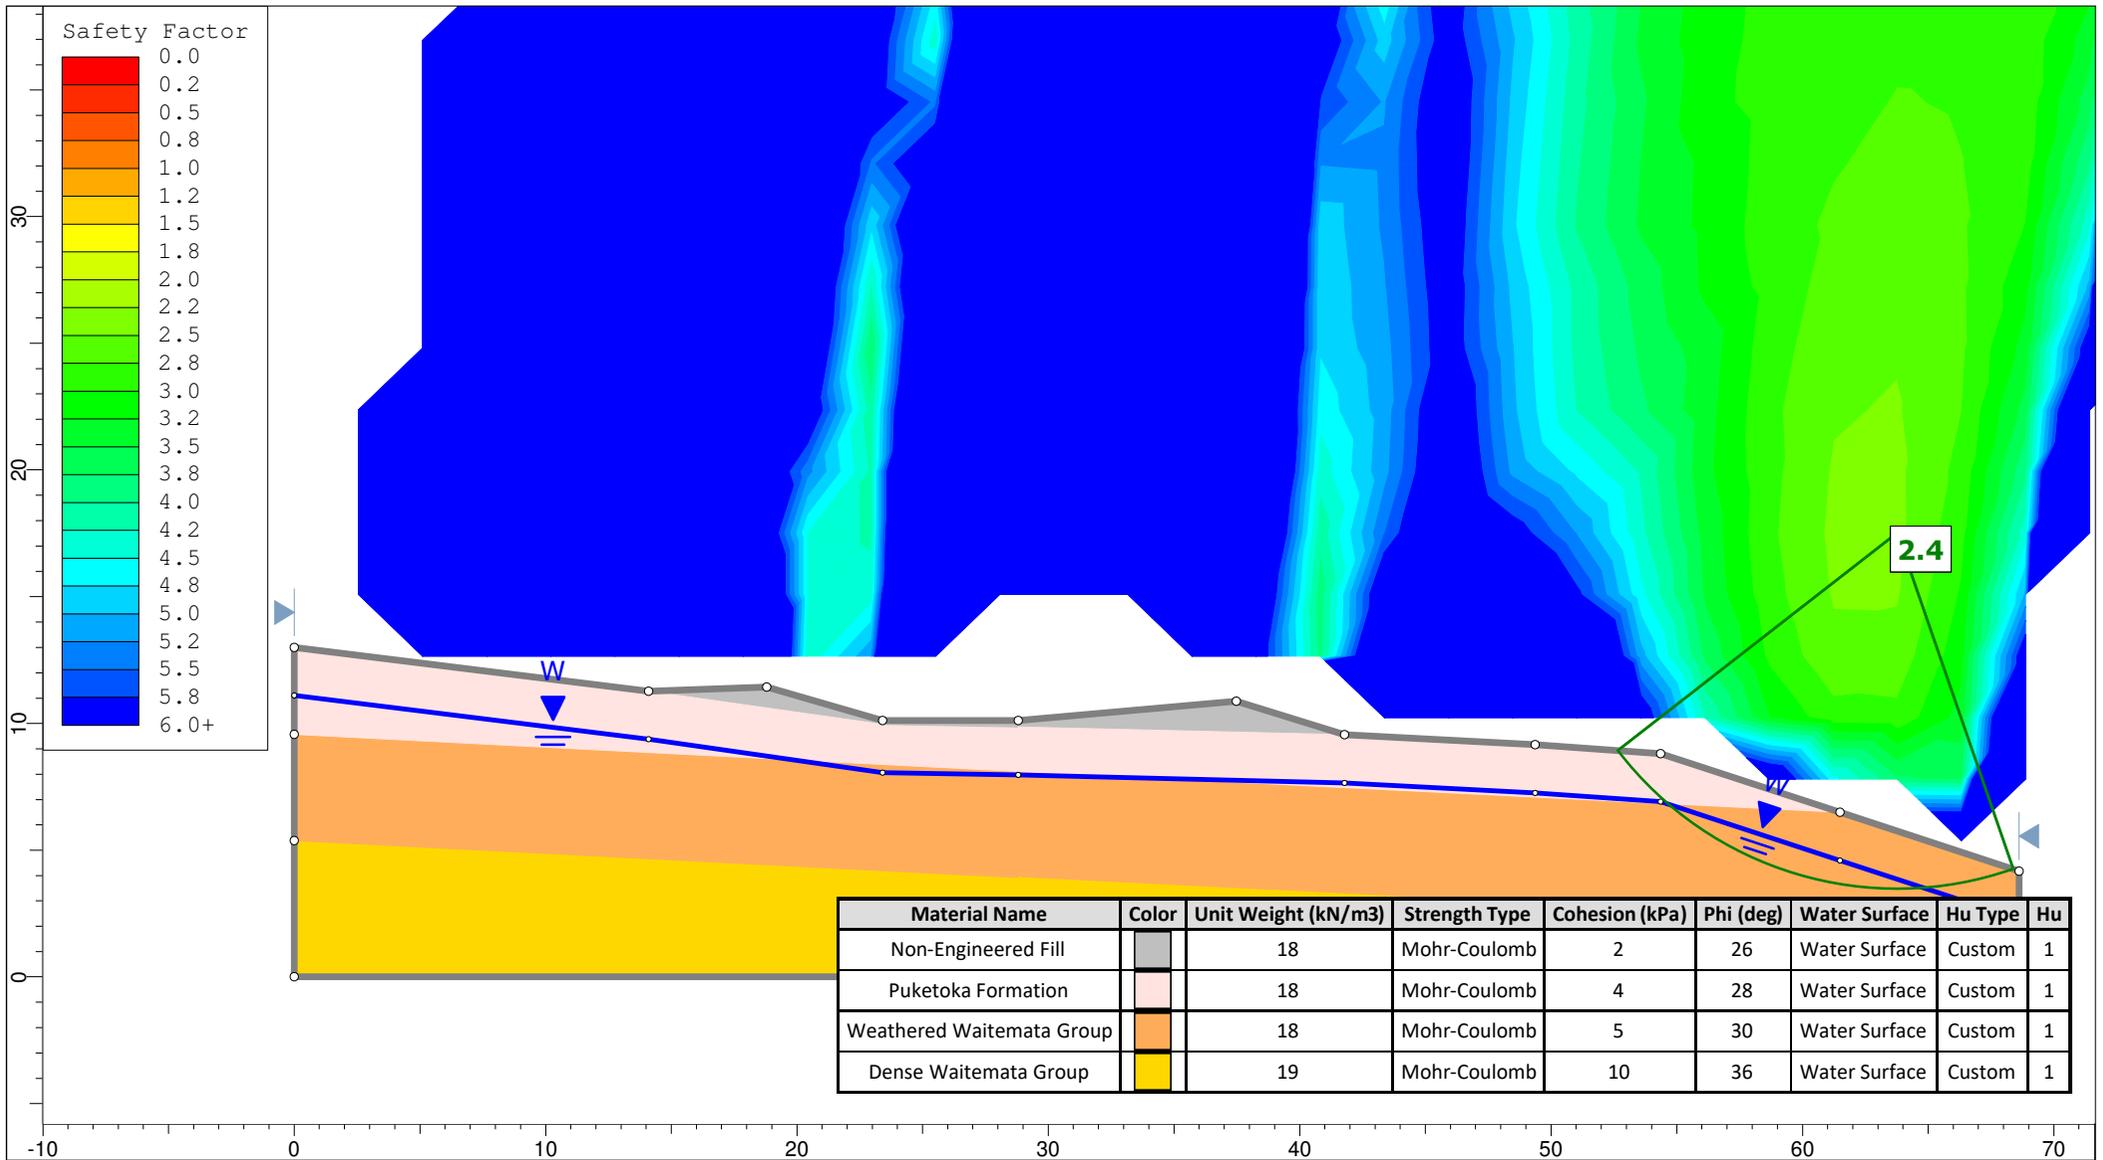
Soil & Rock Consultants <i>Your responsive & cost-effective engineers</i>	Project		39 Launch Road	
	Group		Section BB	
	Scenario		Measured GWT	
	Drawn By		Scale	
Date		File Name		
	MW	1:300	Soil & Rock Consultants	211053 Slide AABB.slmd
	17/11/2021

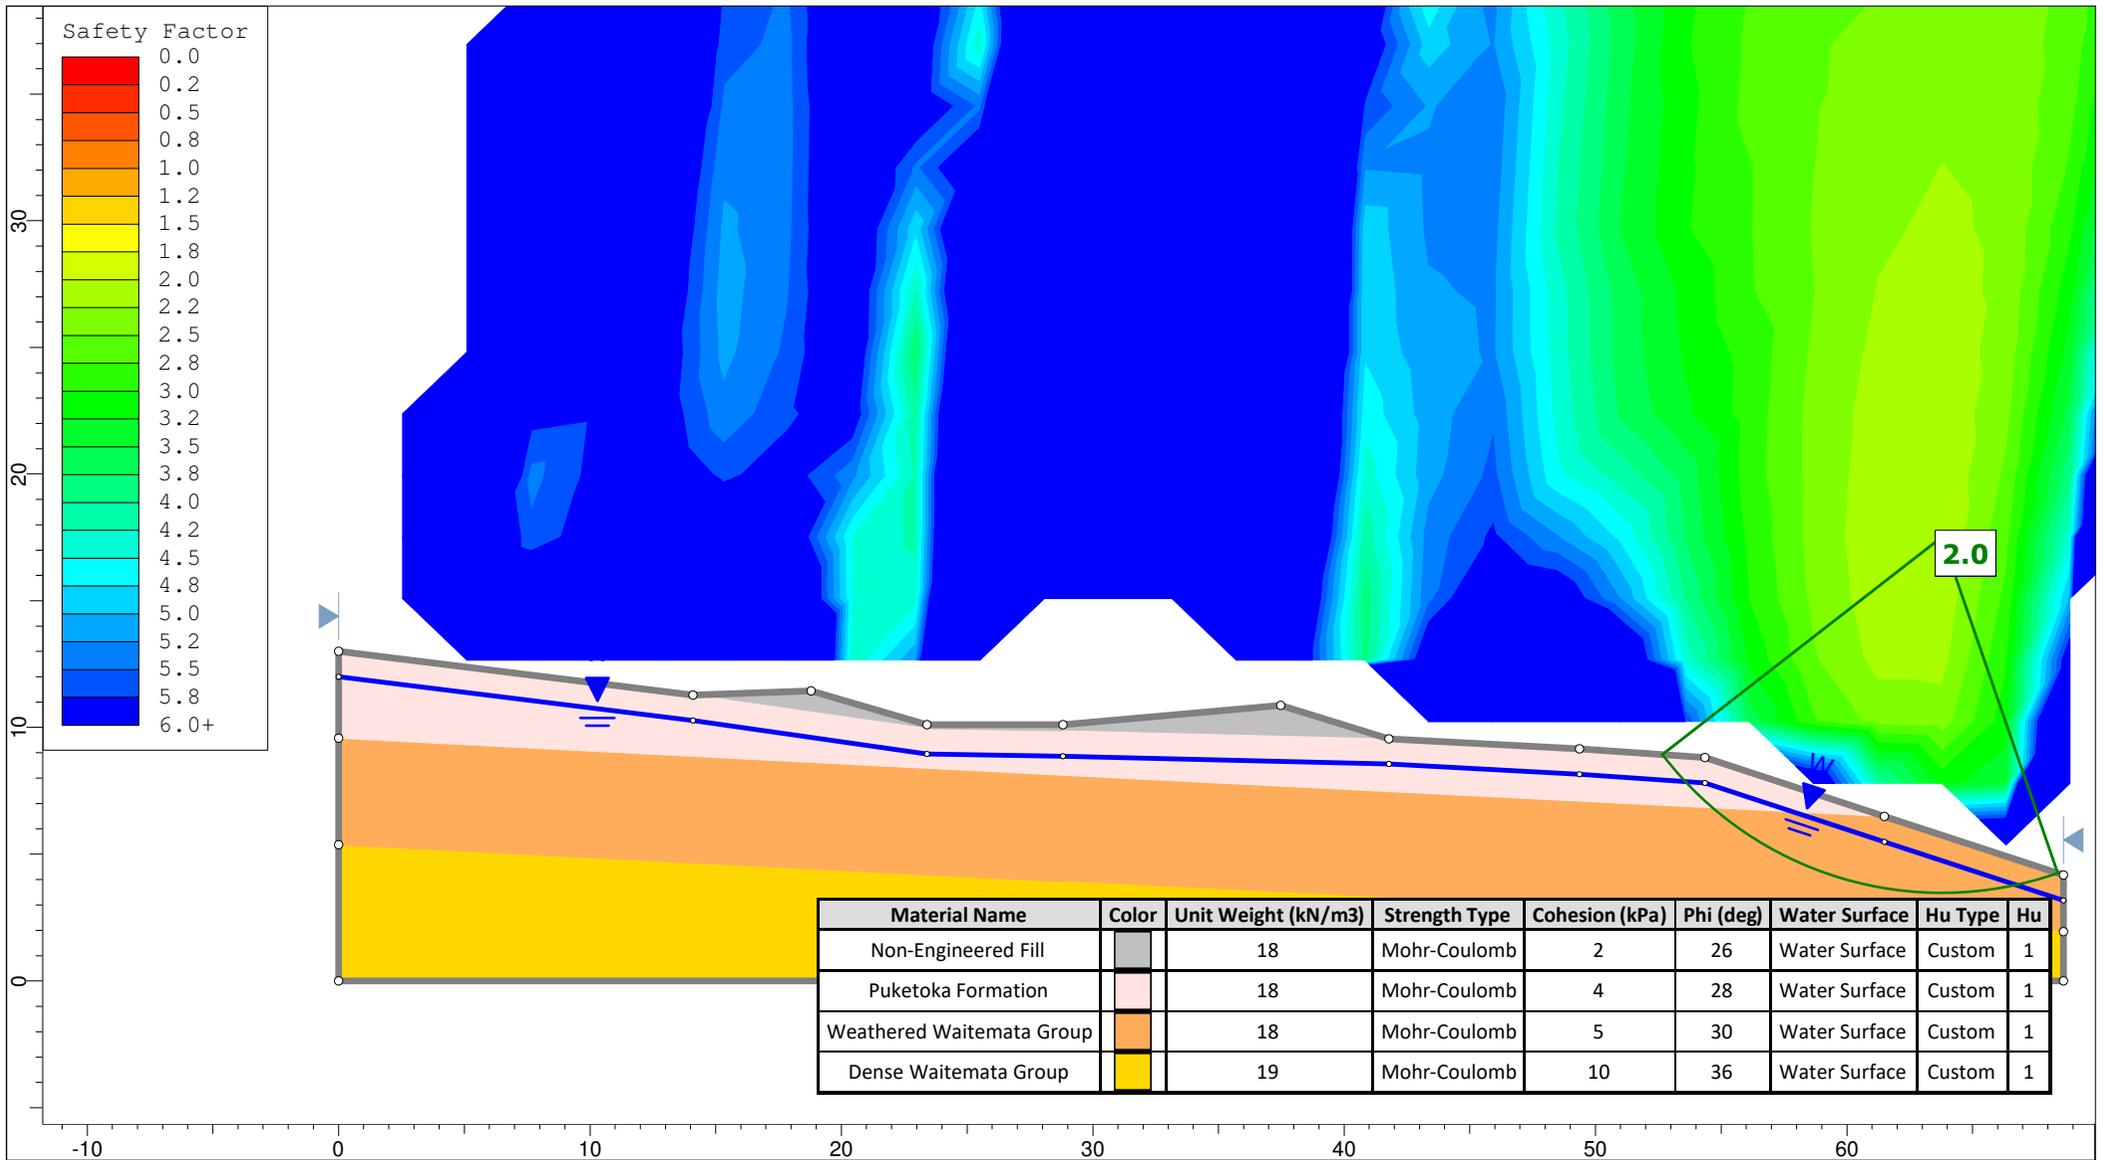
Material Name	Color	Unit Weight (kN/m3)	Strength Type	Cohesion (kPa)	Phi (deg)	Water Surface	Hu Type	Hu
Non-Engineered Fill		18	Mohr-Coulomb	2	26	Water Surface	Custom	1
Puketoka Formation		18	Mohr-Coulomb	4	28	Water Surface	Custom	1
Weathered Waitemata Group		18	Mohr-Coulomb	5	30	Water Surface	Custom	1
Dense Waitemata Group		19	Mohr-Coulomb	10	36	Water Surface	Custom	1

<p>Soil & Rock Consultants Your responsive & cost-effective engineers</p>	Project				39 Launch Road				
	Group		Section BB		Scenario		Raised GWT		
	Drawn By		MW		Scale		1:300		
	Date		17/11/2021		Company		Soil & Rock Consultants		
				File Name		211053 Slide AABB.slmd

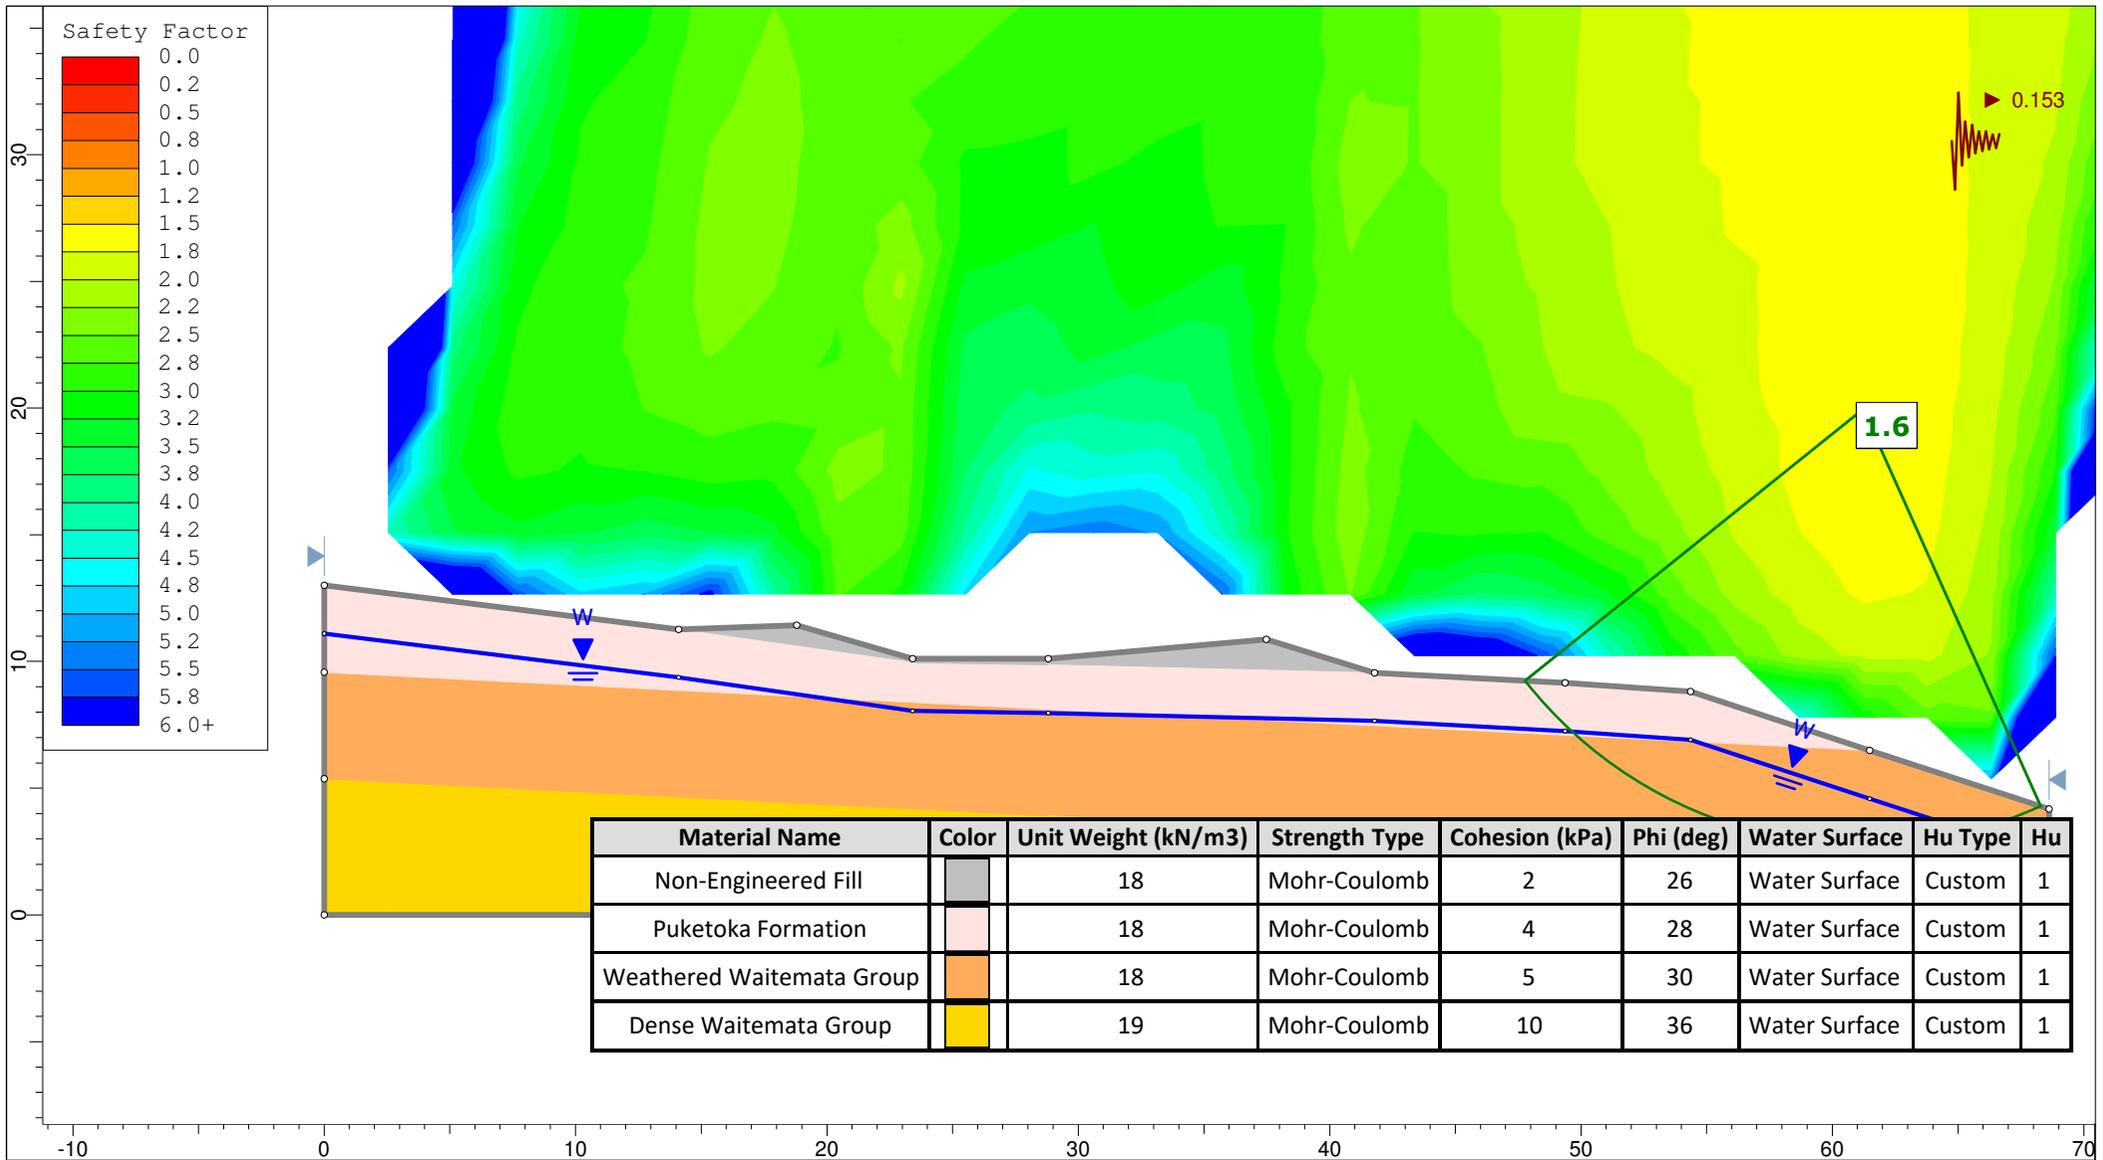
Material Name	Color	Unit Weight (kN/m ³)	Strength Type	Cohesion (kPa)	Phi (deg)	Water Surface	Hu Type	Hu
Non-Engineered Fill		18	Mohr-Coulomb	2	26	Water Surface	Custom	1
Puketoka Formation		18	Mohr-Coulomb	4	28	Water Surface	Custom	1
Weathered Waitemata Group		18	Mohr-Coulomb	5	30	Water Surface	Custom	1
Dense Waitemata Group		19	Mohr-Coulomb	10	36	Water Surface	Custom	1
